Property Address, Pa

INSPECTION CENTER

by Mike Biechler Inc.

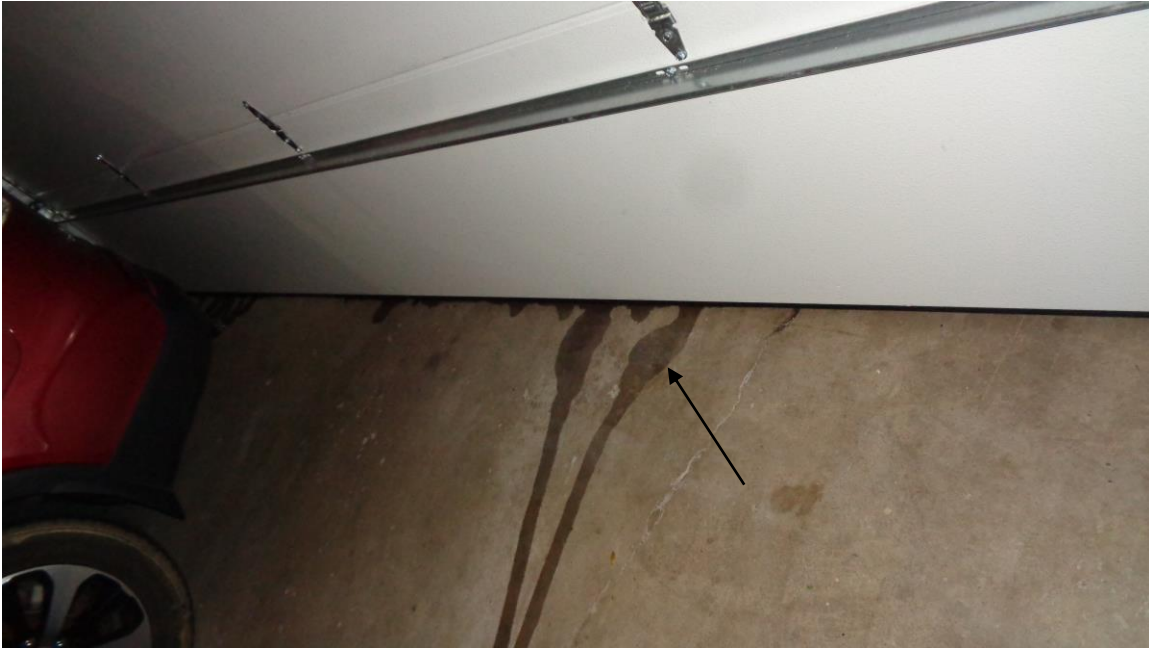
- Water leaking in under the garage door when it rains hard.

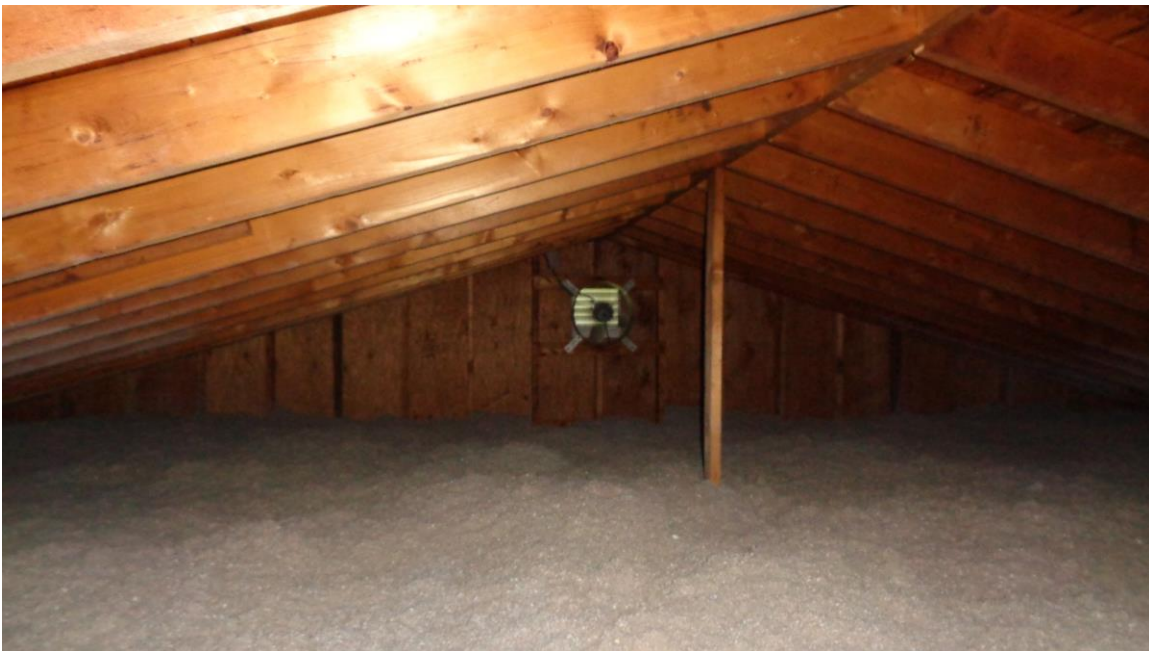
- The attic is very hot. You would benefit by adding additional ventilation in the attic.

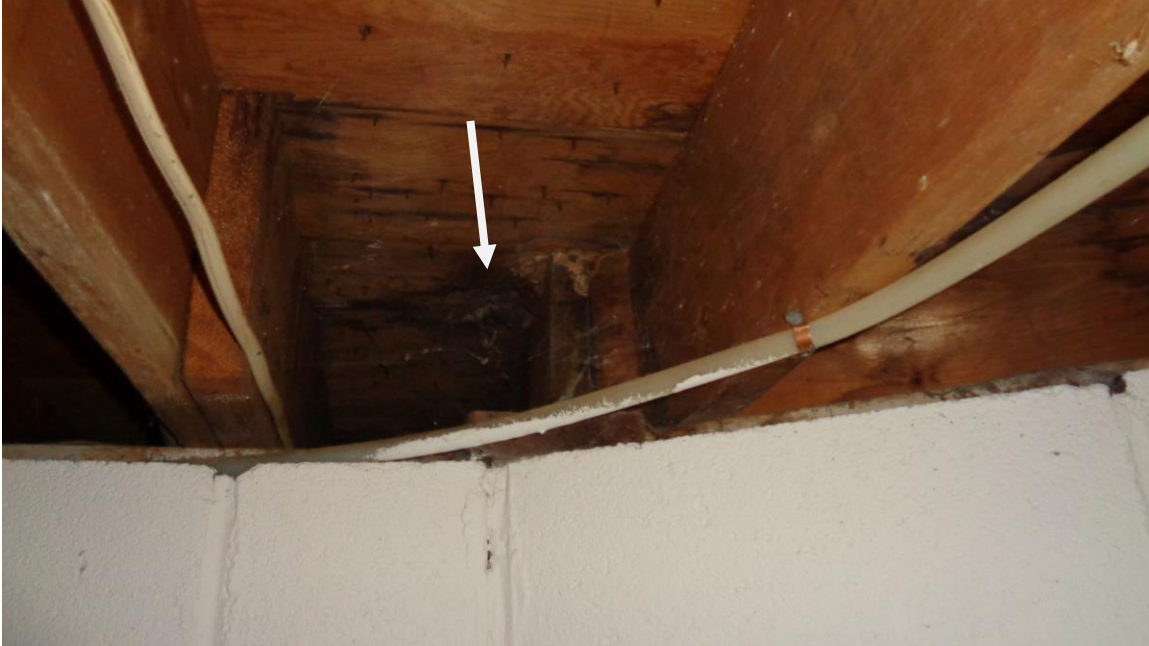
- Rotted wood under the exterior door out of the laundry room. This is visible from the basement. The door has been replaced. Monitor for further deterioration.

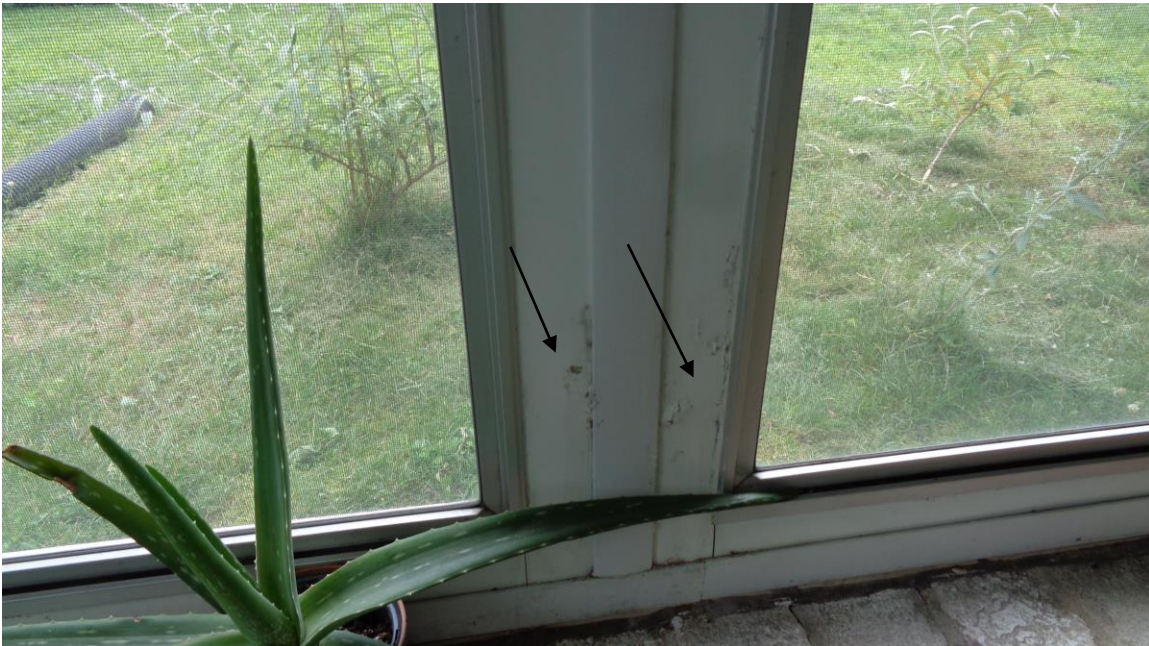
- The sunroom is a manufactured room. The panels that hold the windows are made of wood that have a laminated finish. The finish is pitted and starting to delaminate. The wood inside is starting to deteriorate. Caulking the seams will slow down the rot process. Budget to replace.

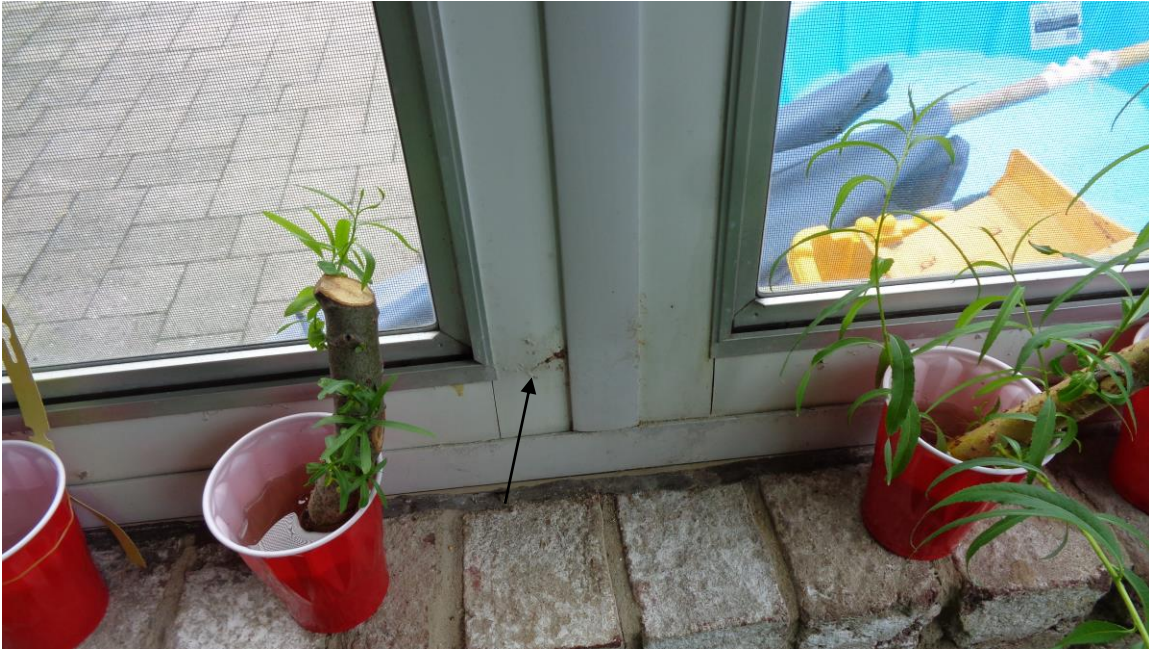
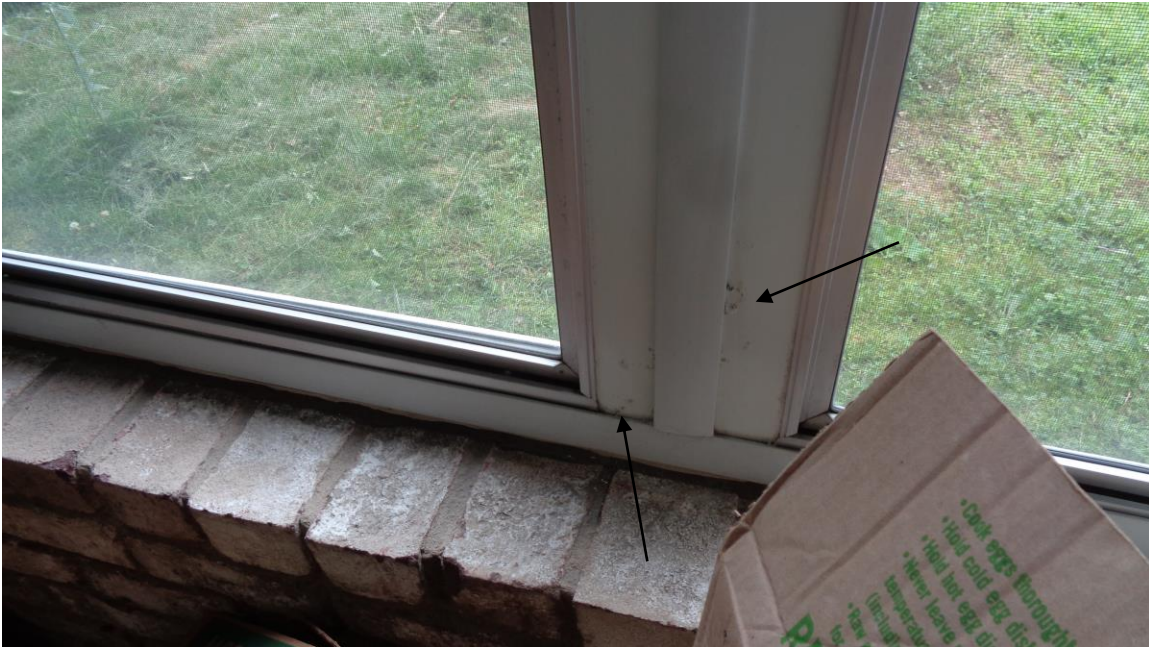
- The sunroom is a manufactured room. The panels that hold the windows are made of wood that have a laminated finish. The finish is pitted and starting to delaminate. The wood inside is starting to deteriorate. Caulking the seams will slow down the rot process. Budget to replace.

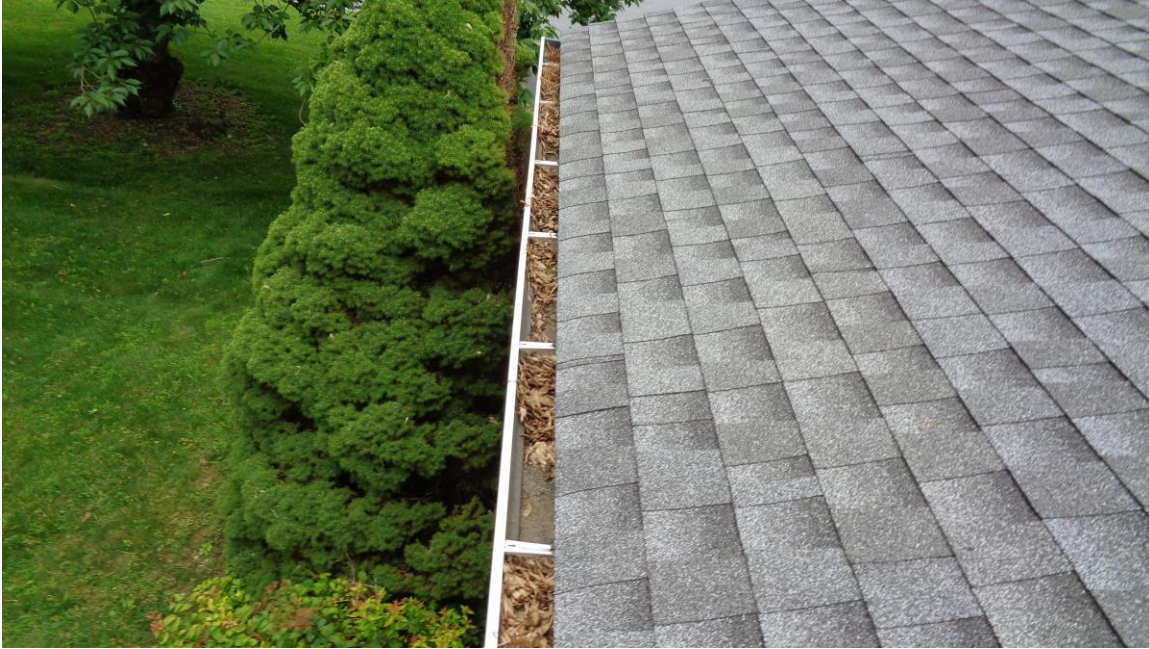
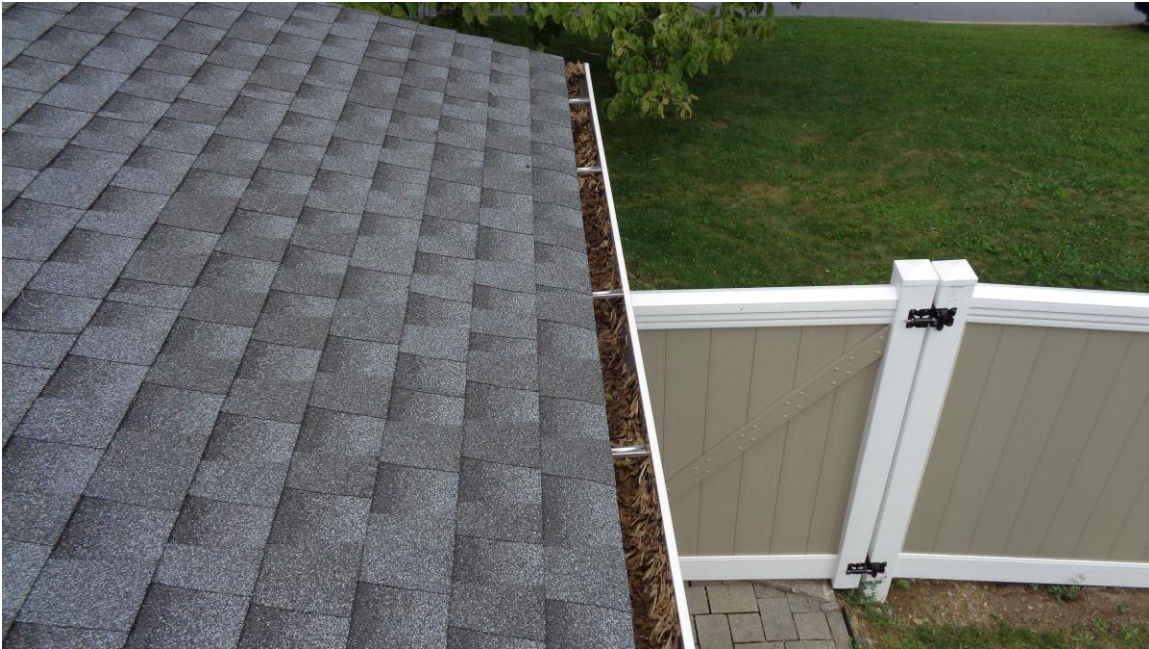
- Clean the gutters on the left side of the house.

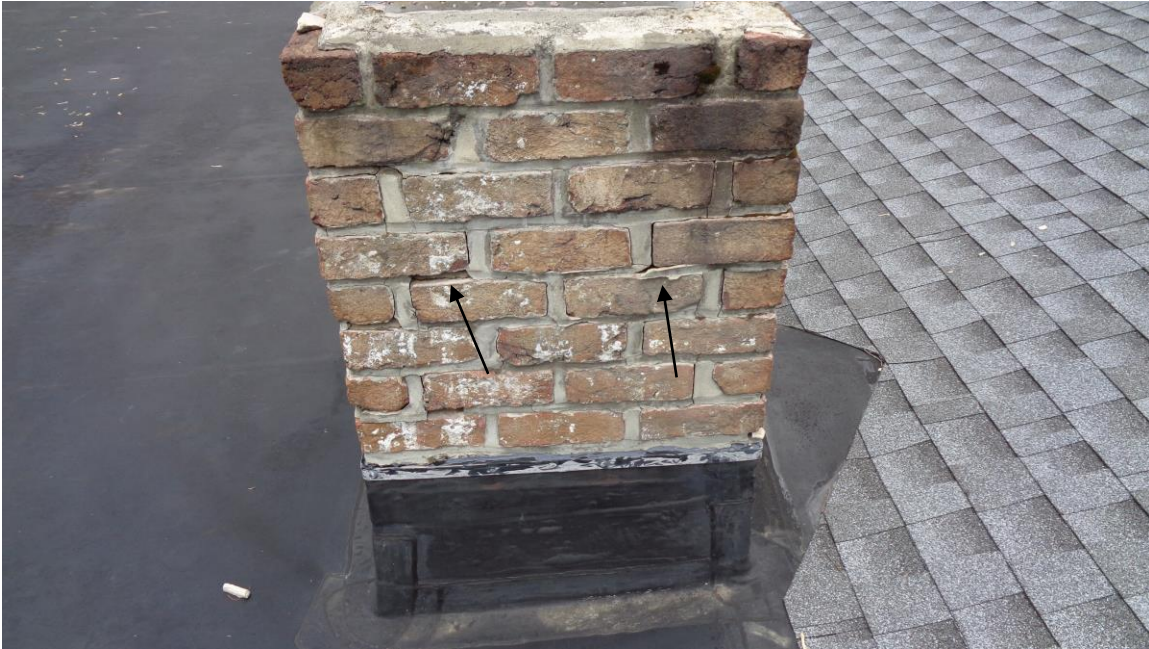
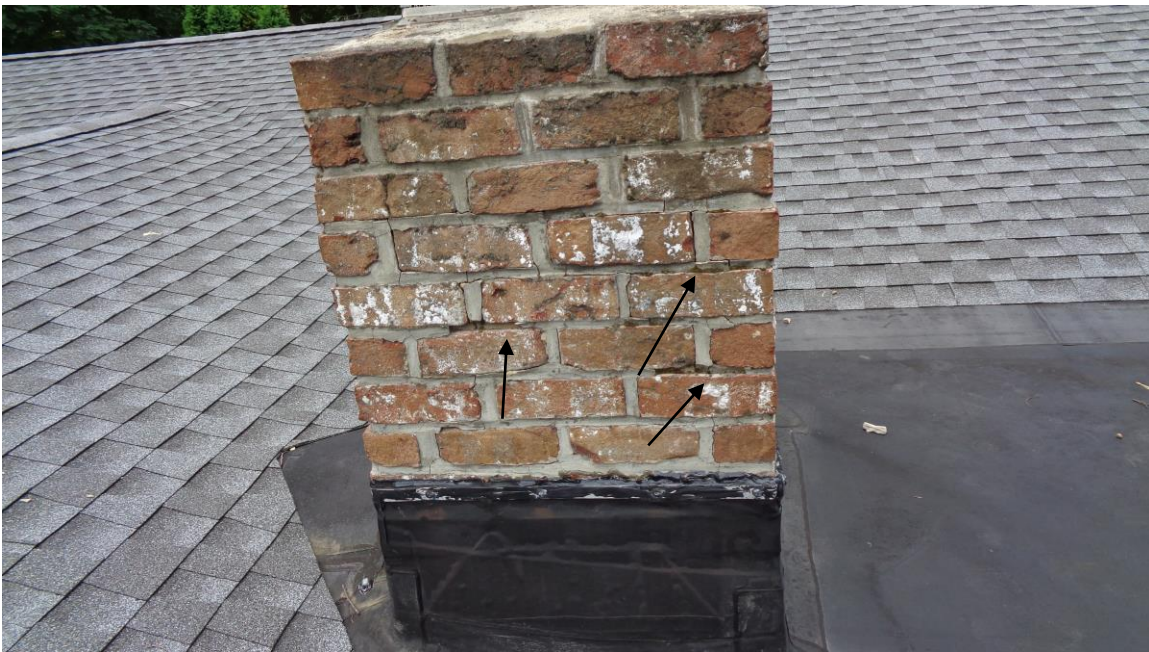
- Cracks and gaps in the mortar between a few of the brick on the chimney. The chimney needs pointed.

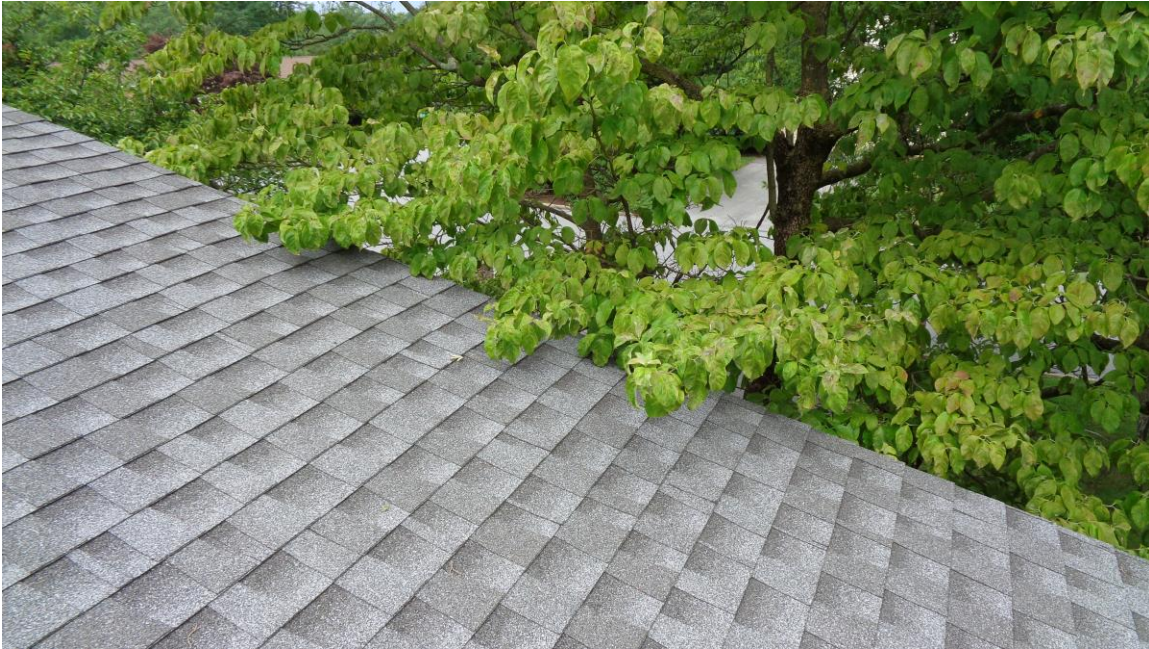
- Trim tree limbs trimmed back off the shingles and siding.

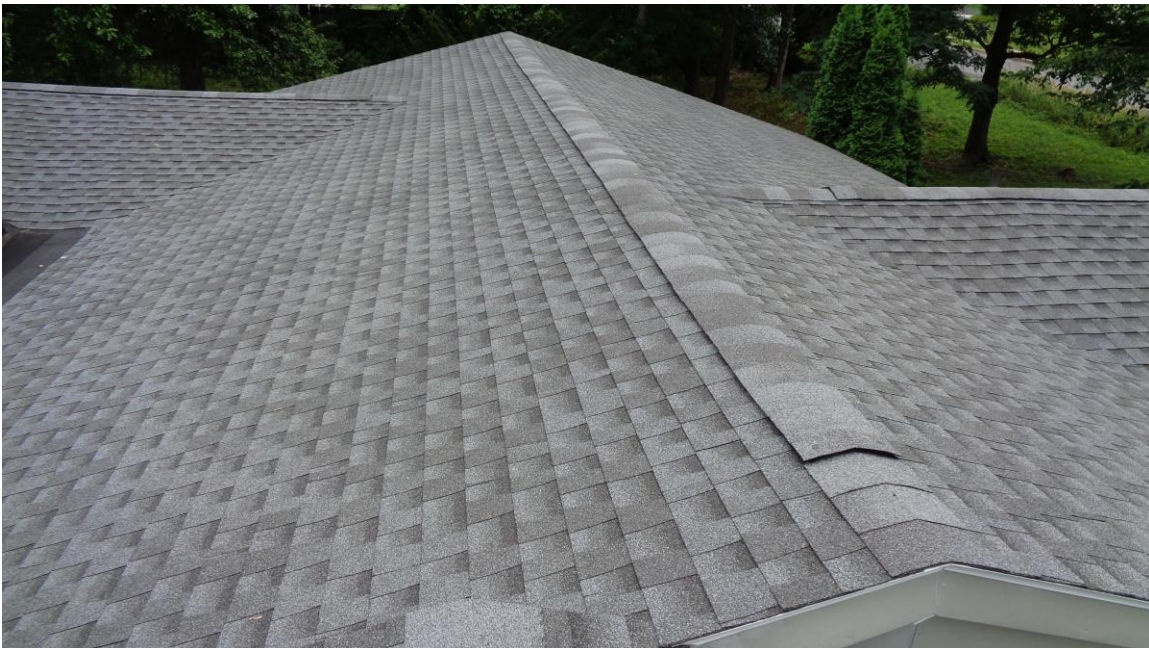
- The architectural shingles are in good condition and typically last 30+ years.

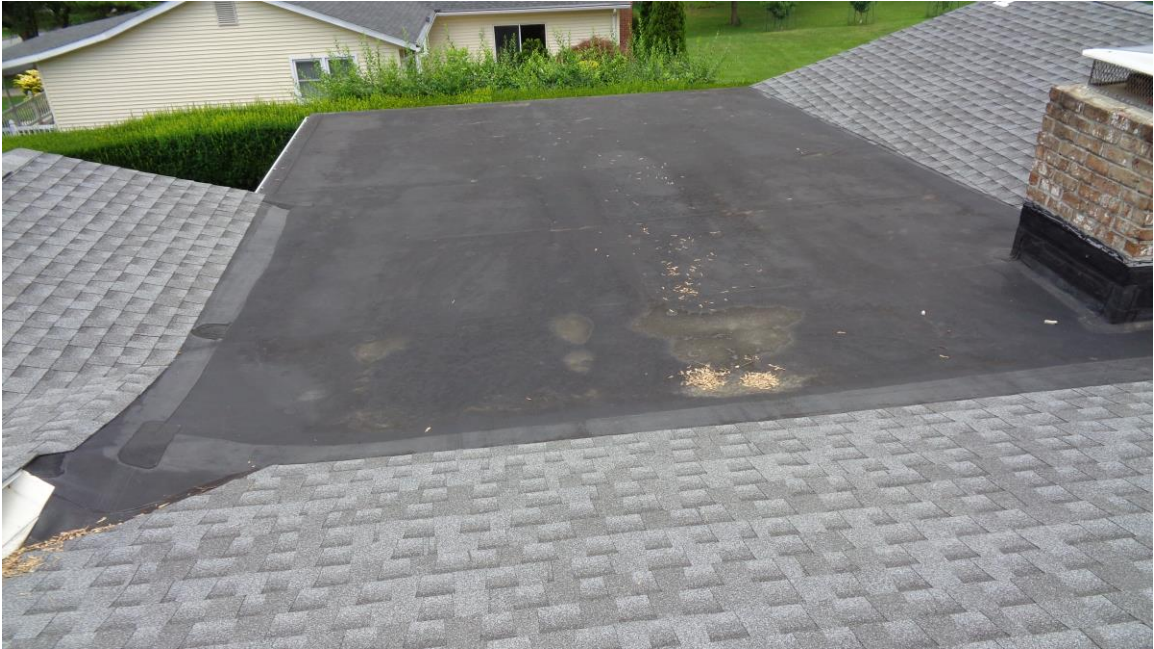
- The rubber roof material is in good condition.

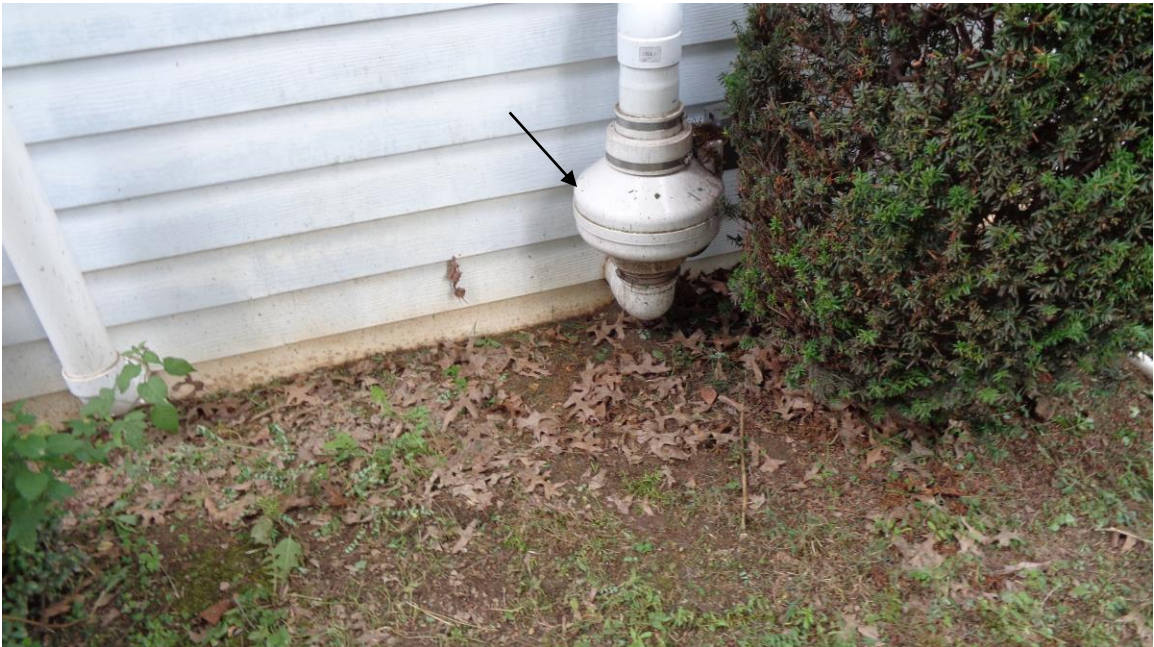
- The radon fan was running.

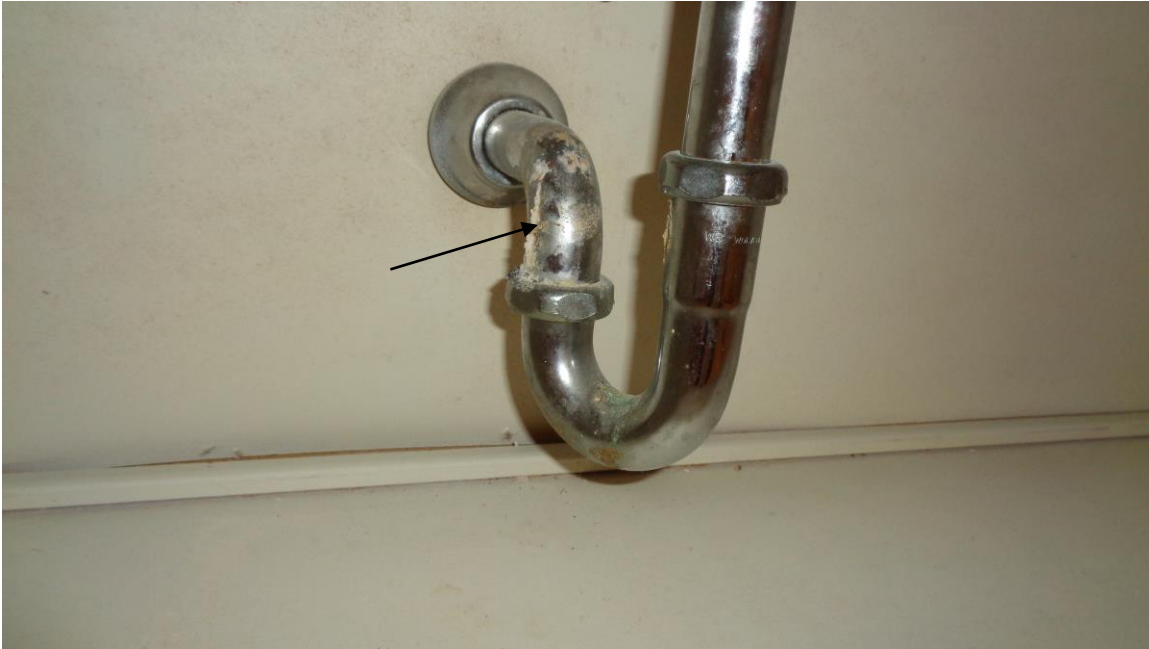
- The bathroom sink traps are pitted under most of the sinks. Replace within the next year.

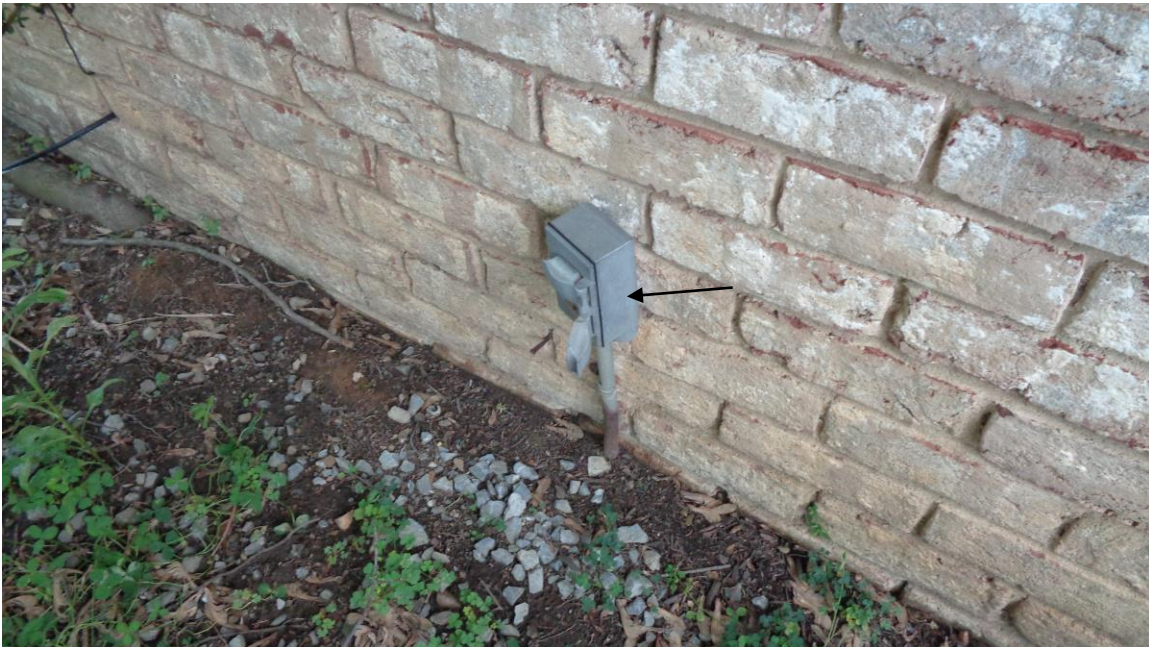
- No power and loose receptacle on the left exterior wall.

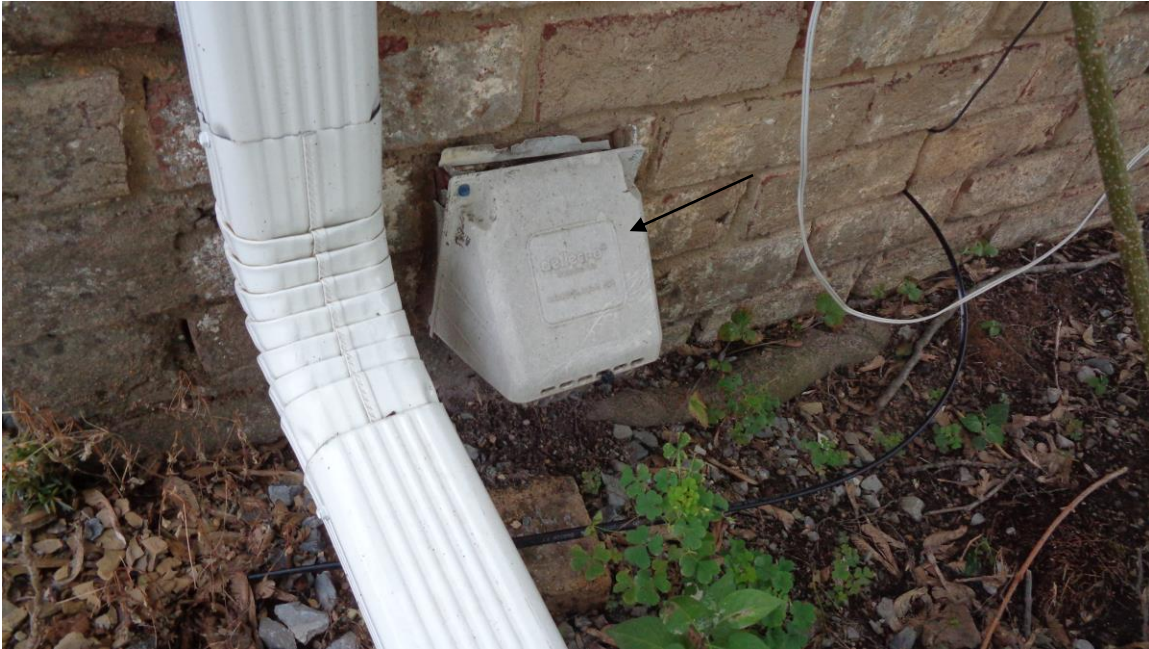
- Dryer vent needs cleaned.

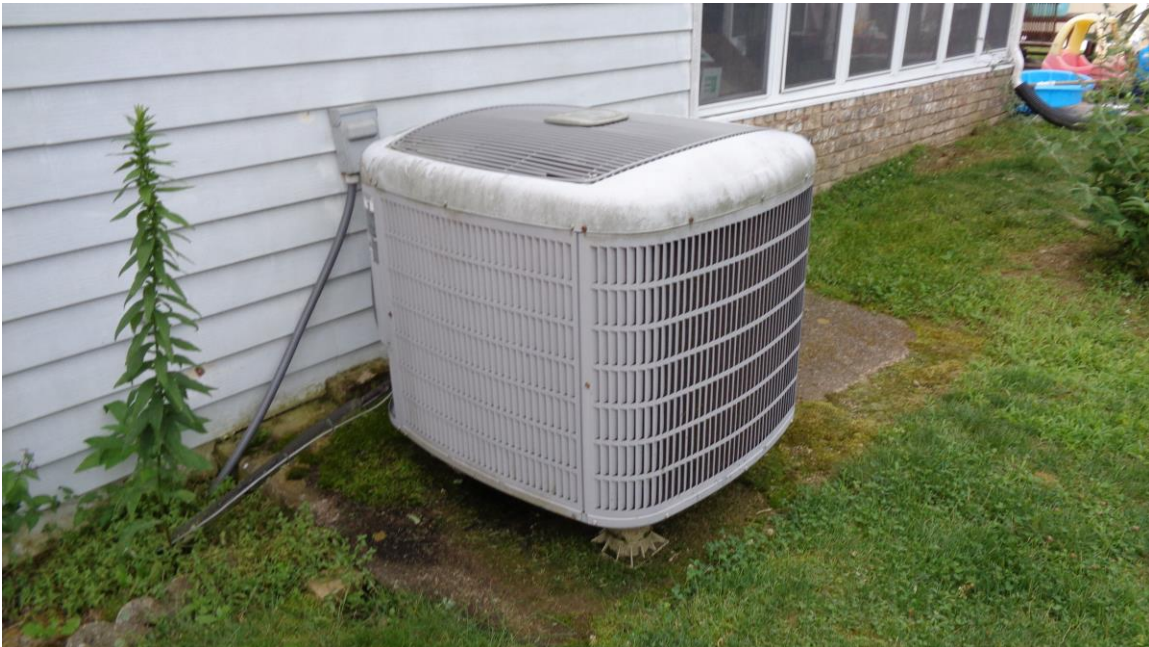
- The air conditioner operated from the thermostat and provided cool air. Temperature differential of about 20 degrees which is good. MFD: 2013. Service yearly.

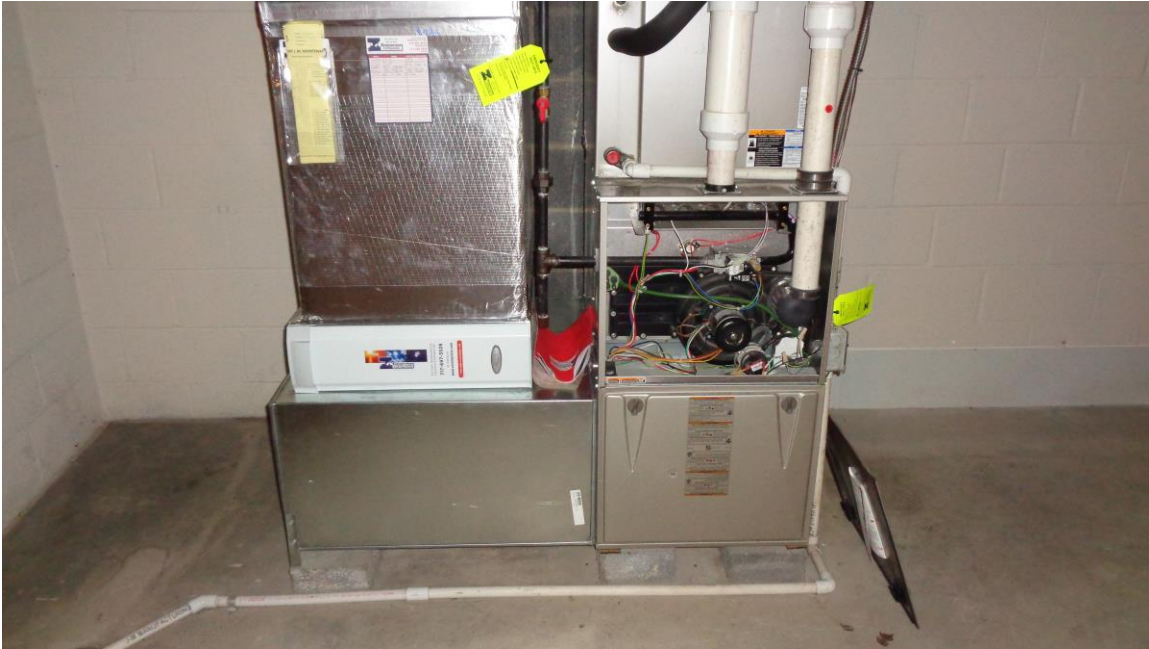
- The furnace operated from the thermostat and provided warm air. Heat rise was within manufactures specifications. MFD: 2013. Service yearly.

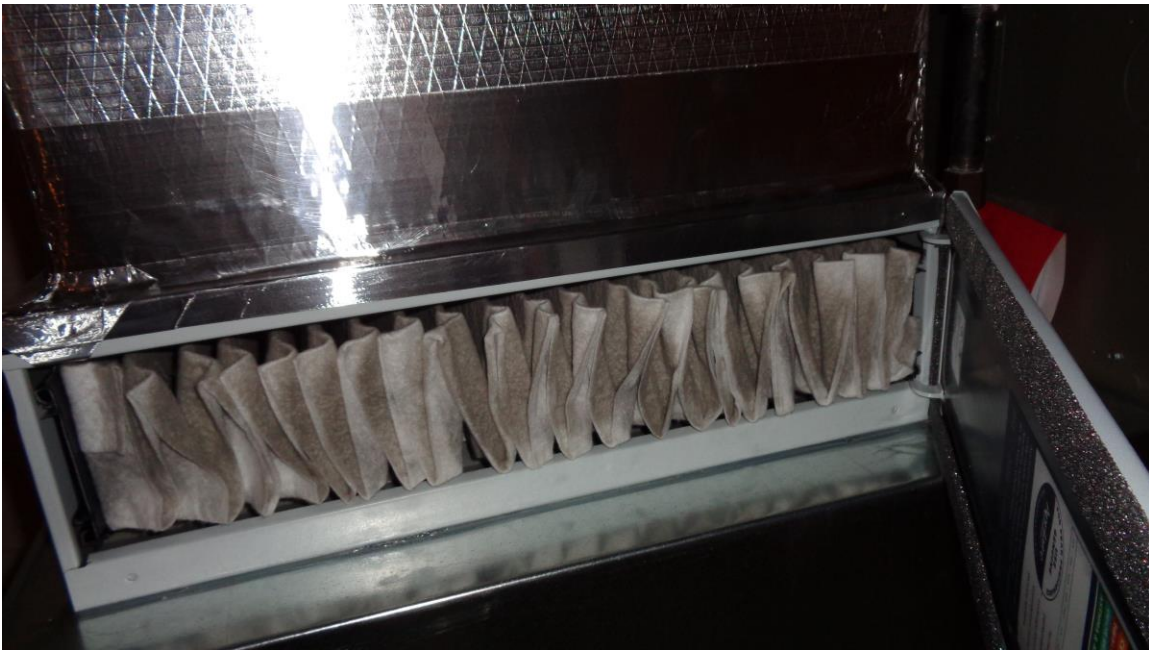
- Change filter every 6 months to 1 year

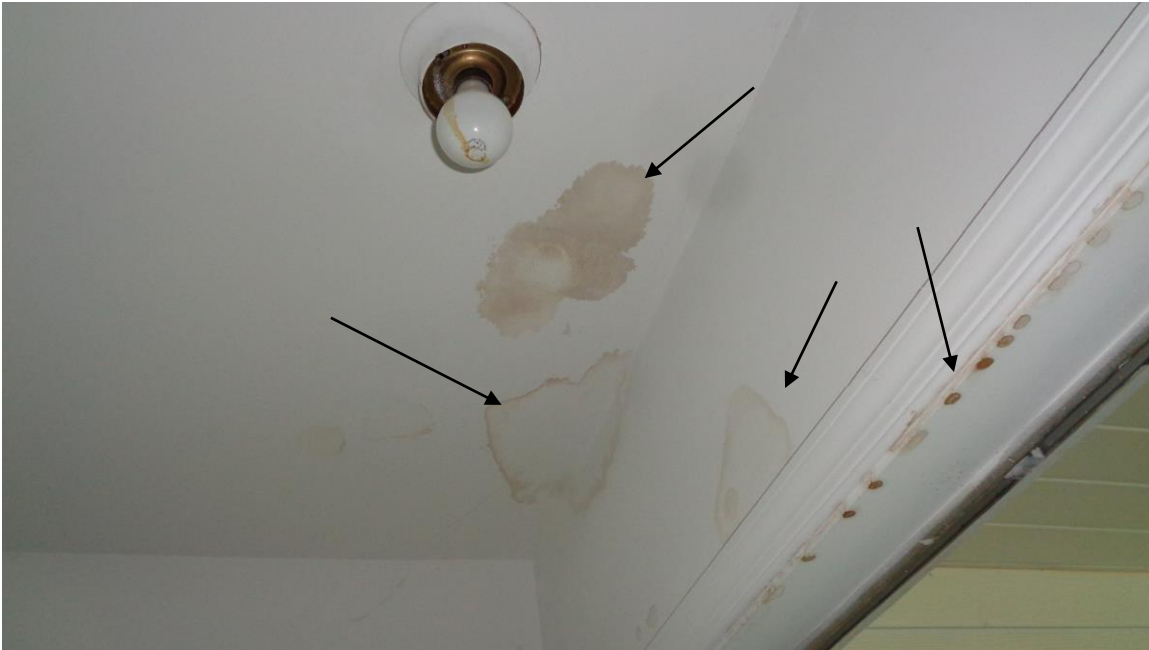
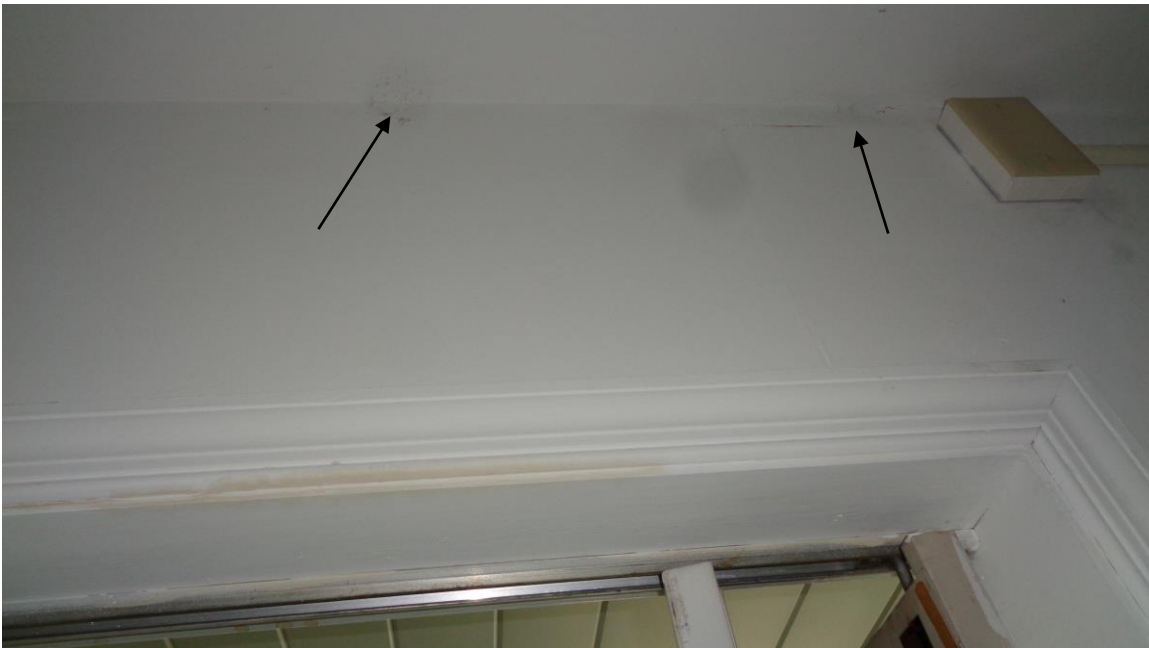
- There are stains in the ceiling in the sunroom. This appears to be from water leaking where the rubber roof intersects the shingles. I recommend the shingles be lifted in this area to see how the rubber roof is sealed.

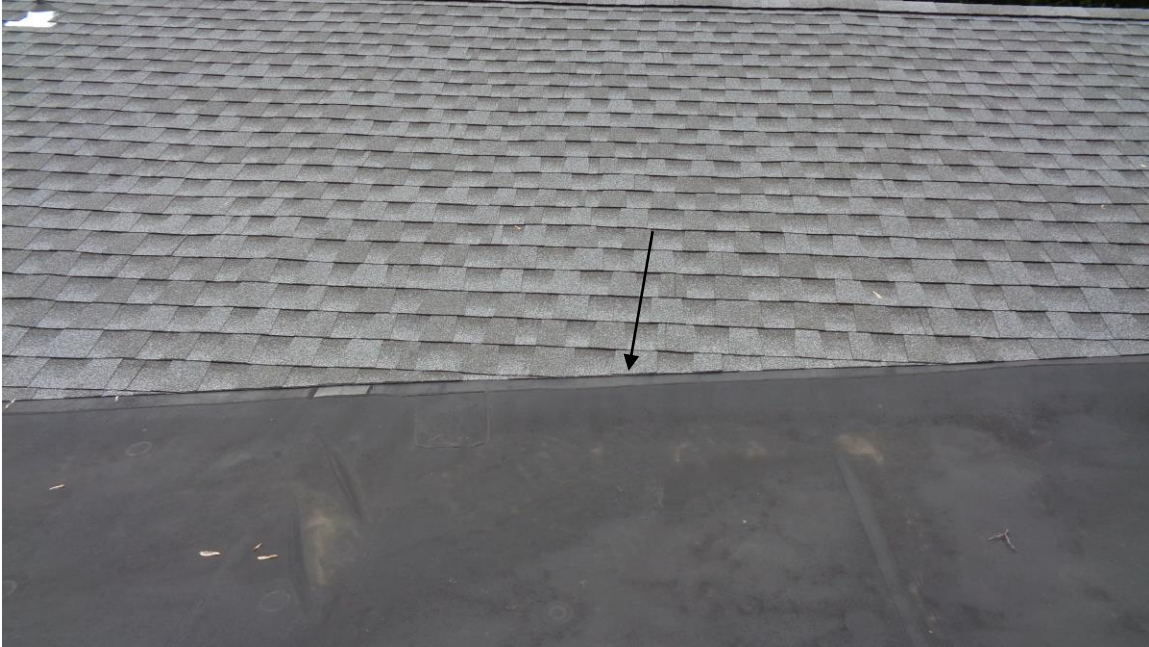
- There are stains in the ceiling in the sunroom. This appears to be from water leaking where the rubber roof intersects the shingles. I recommend the shingles be lifted in this area to see how the rubber roof is sealed.

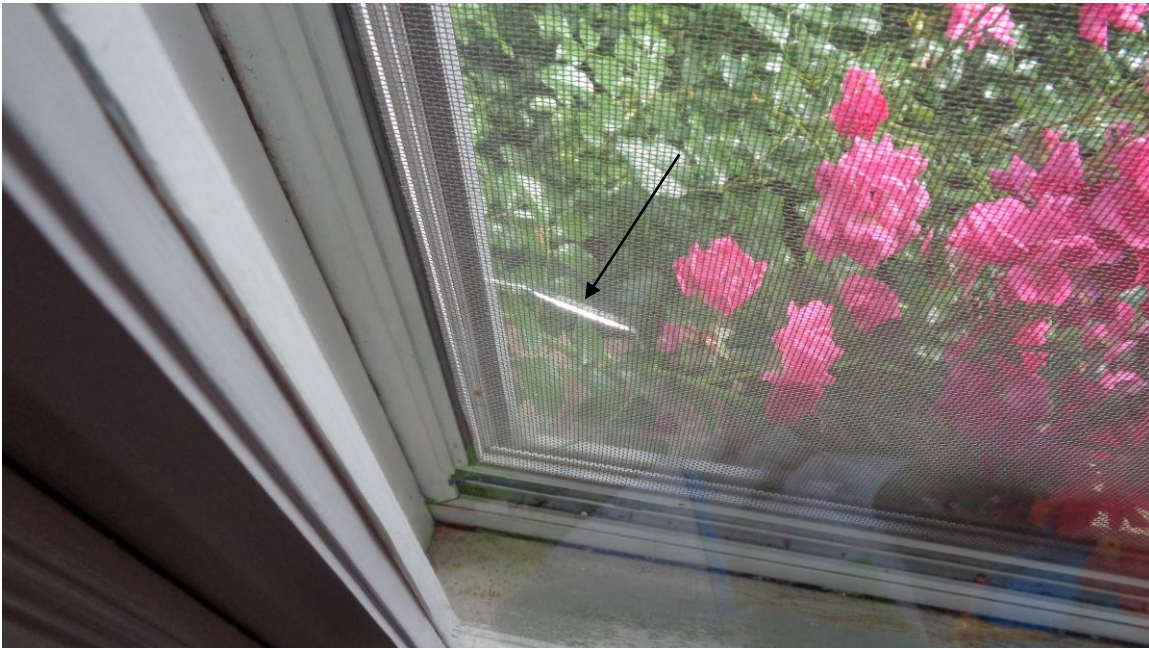
- Glass in the storm window cracked – front right bedroom.

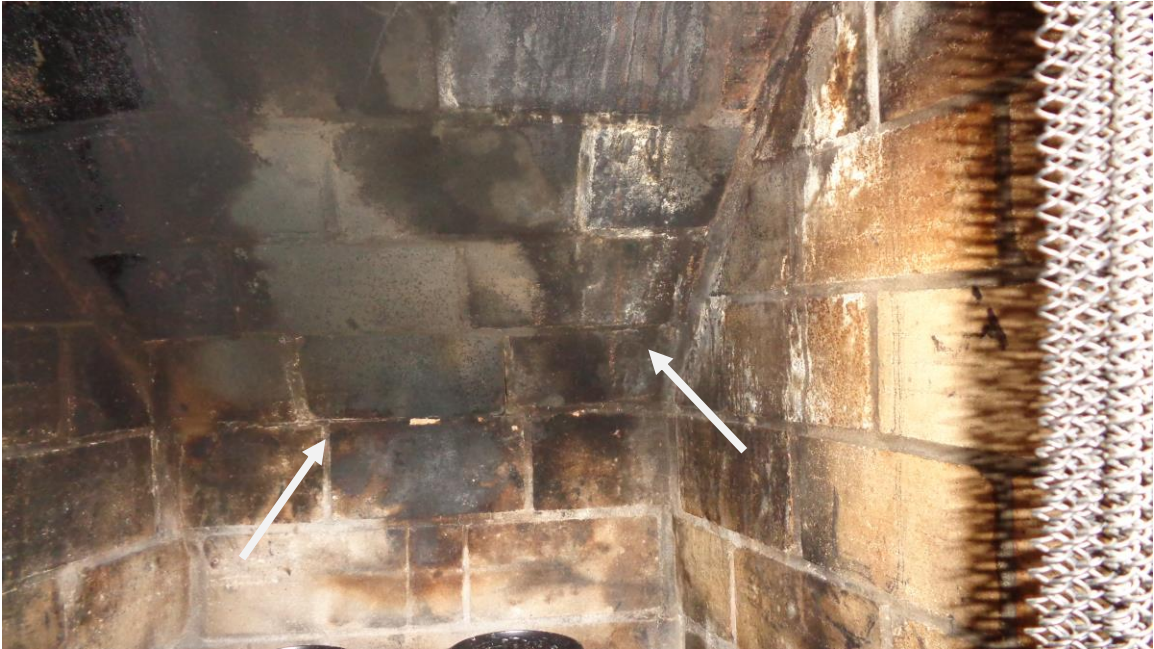
- Gaps in the mortar between the brick in the fireplace burn chamber. The gaps should be filled with mortar before used.

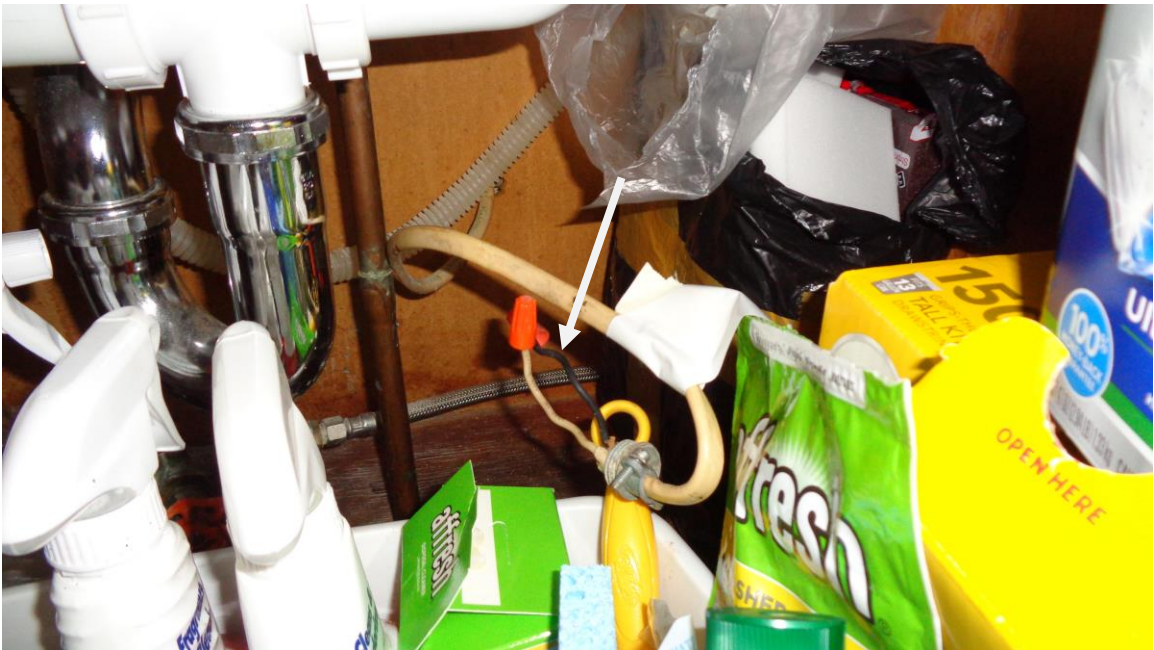
- There is a wire under the kitchen sink for a garbage disposal. The wire only ends with a wire nut. The wire should end in a junction box.

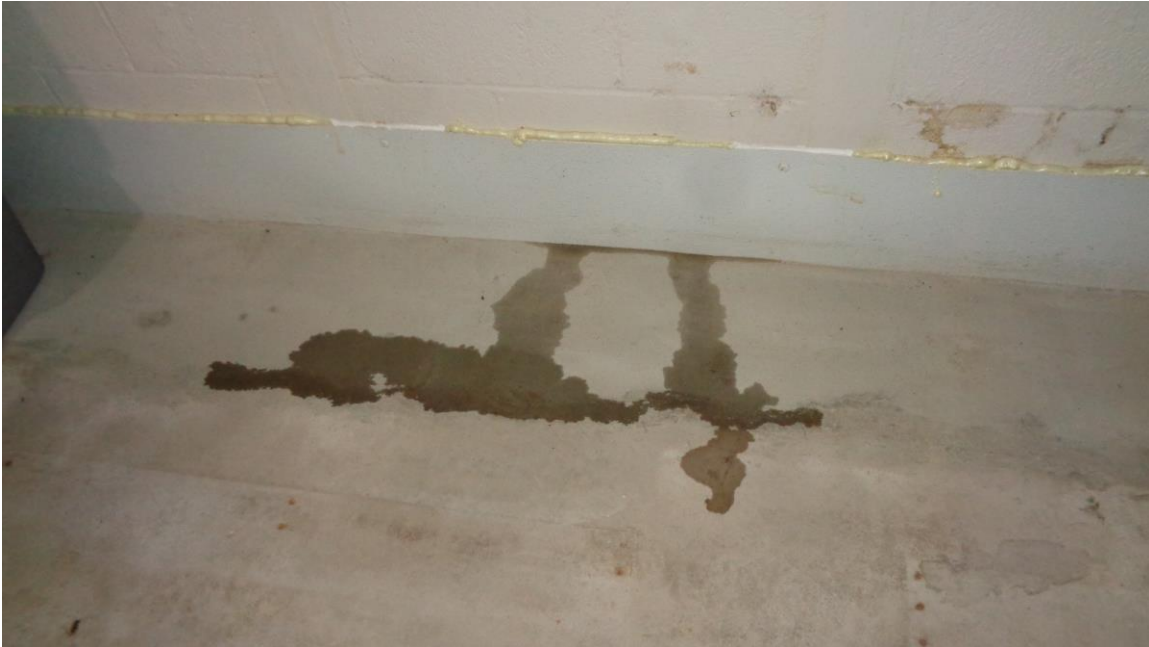
- The age of the house and construction method never intended on providing a dry basement. Water on the floor at time of inspection.
- I recommend contacting the basement water proofing contractor about the water that has come through their system.
- An interior foundation drainage system was installed. This should lower the chance of water leaking into the basement
