Property Address, Pa

INSPECTION CENTER

by Mike Biechler Inc.

Full Home Inspection
Wood Pest Inspection
EIFS Inspection
Radon Testing
Water Testing
Mold Testing

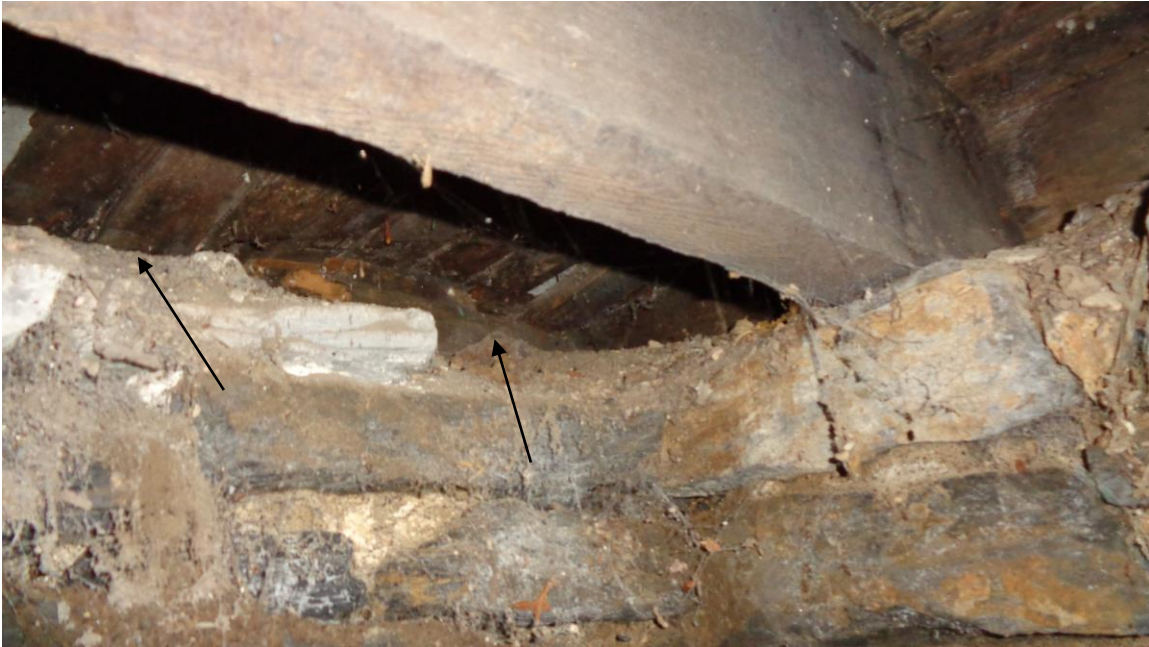
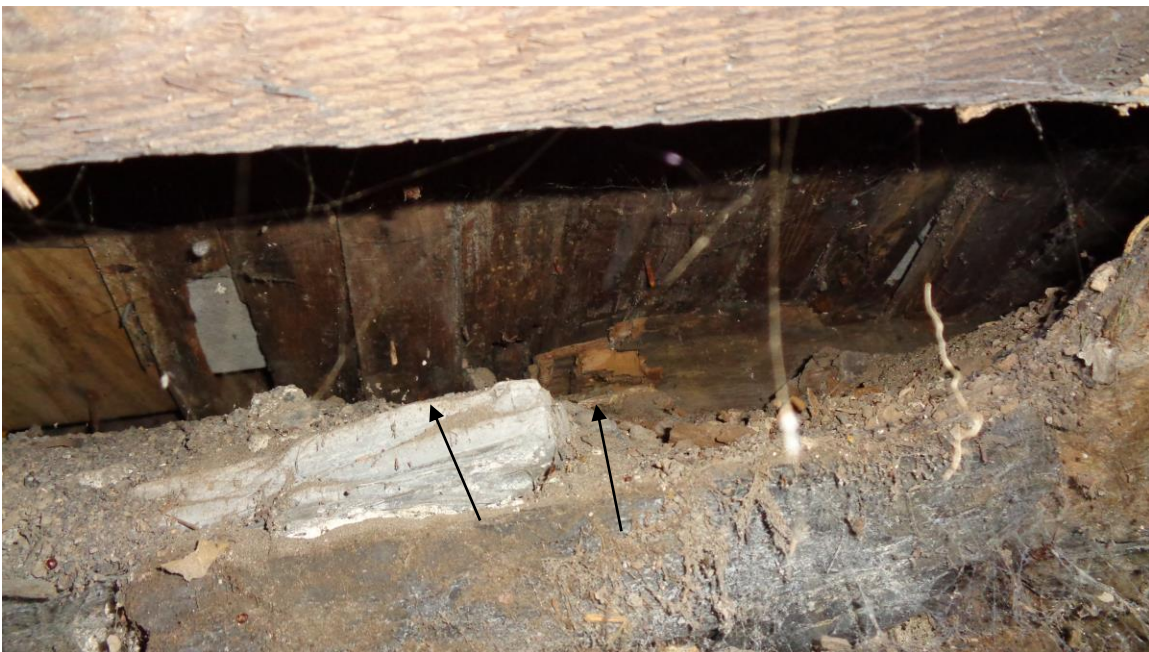
- The sill plate and rear rim joist is rotted at the rear of the basement. These area needs reinforced.

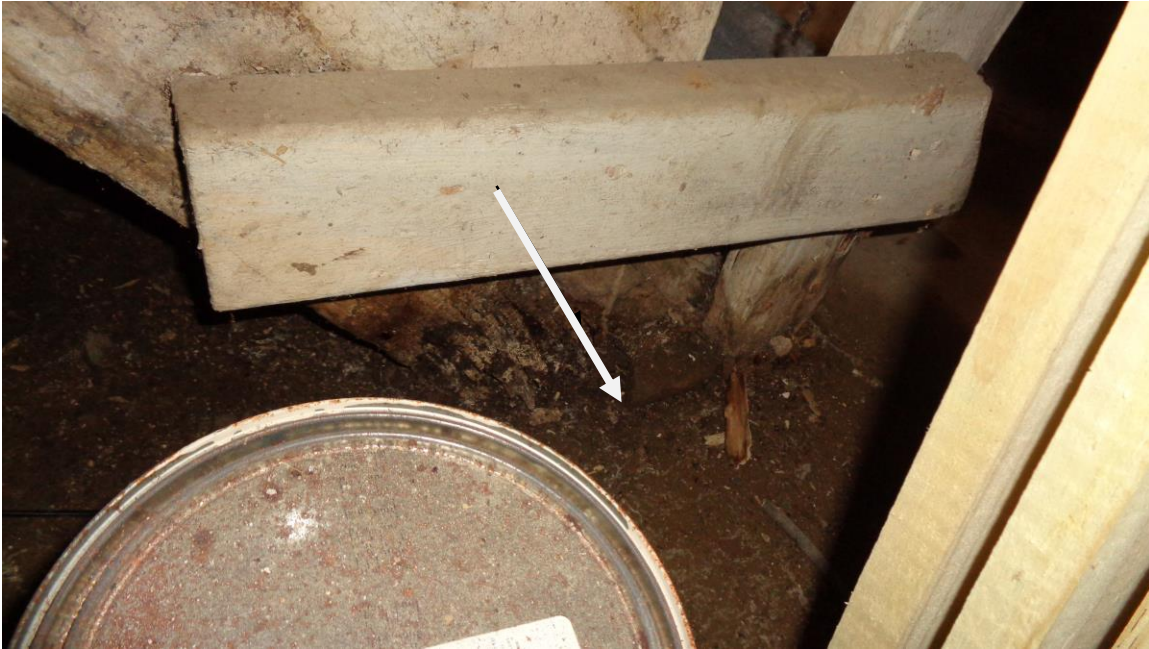
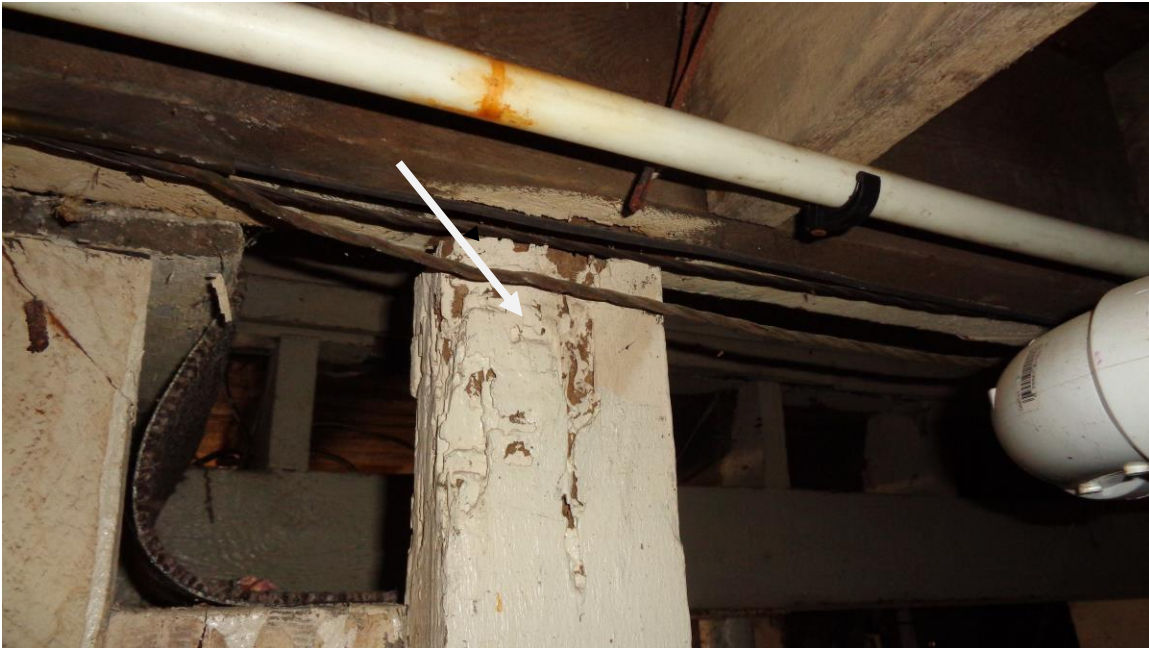
- Rotted/termite damage wood support and rotted/termite damage stringers on the basement steps. The steps should be repaired.

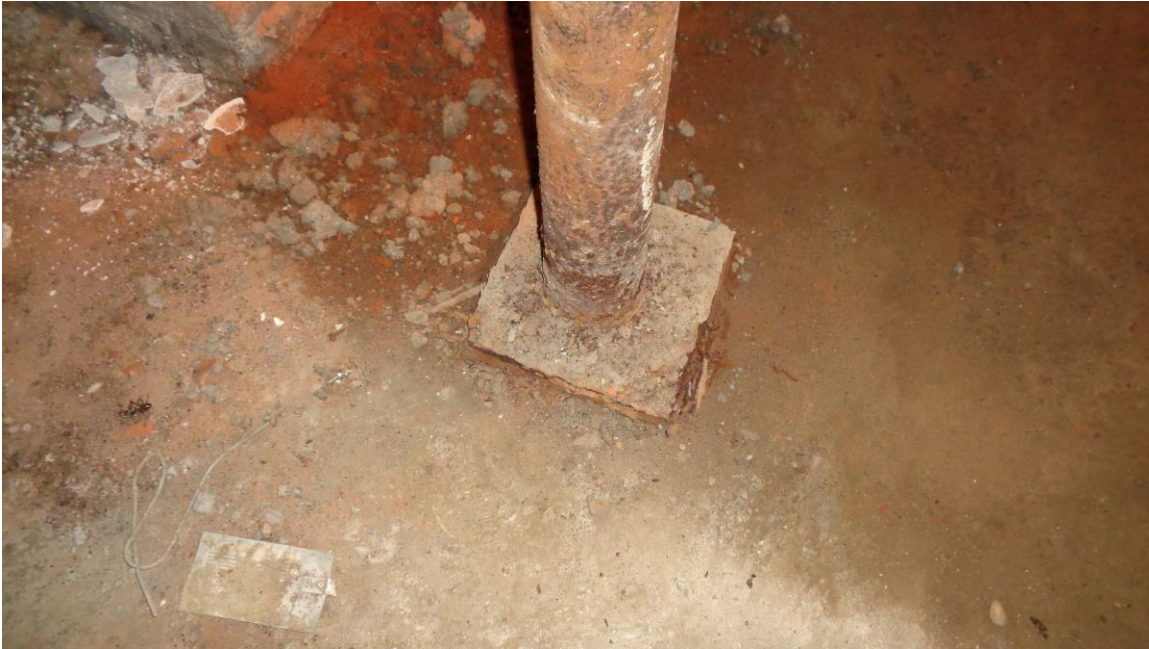
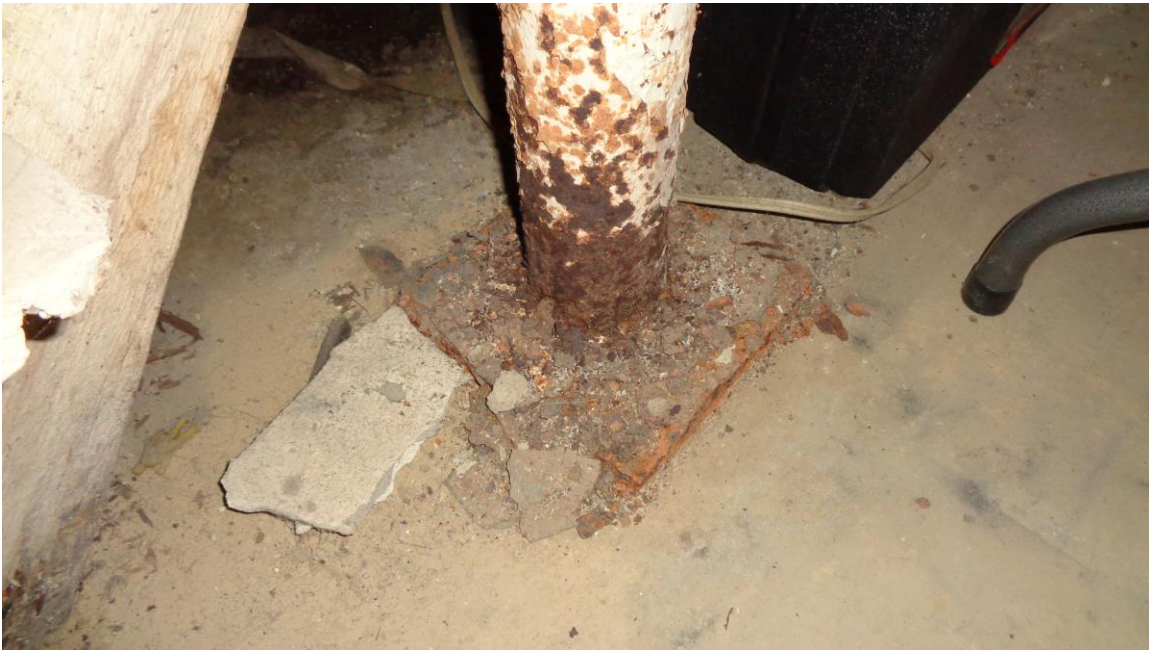
- The bottom of the metal support posts are rusted in the basement. These posts need painted to prevent further rust.

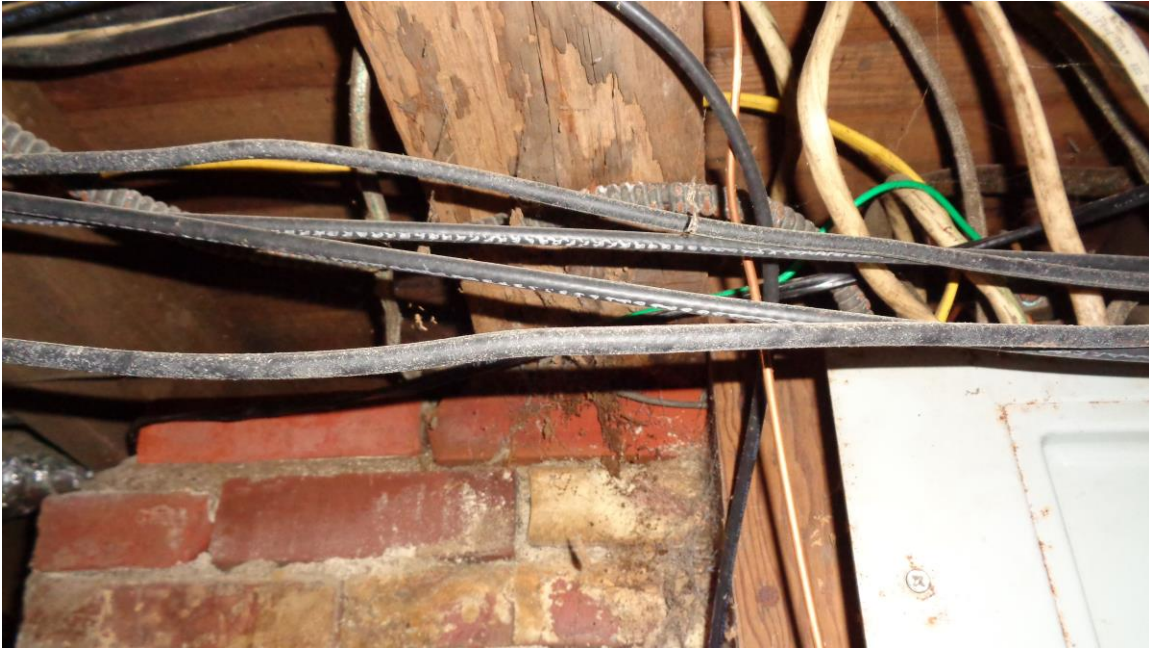
- I found no visible evidence of any major structural damage from the past termite and wood boring beetle activity in the basement.

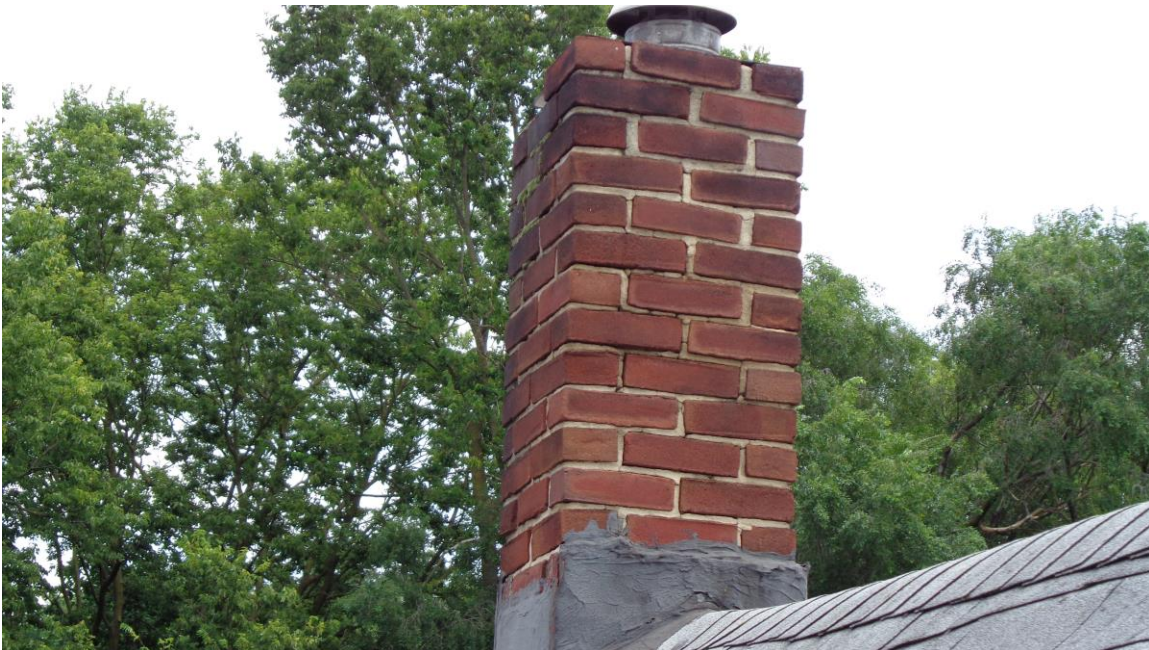
- Loose brick and mortar on the chimney. I recommend a mason evaluate and repair as needed.

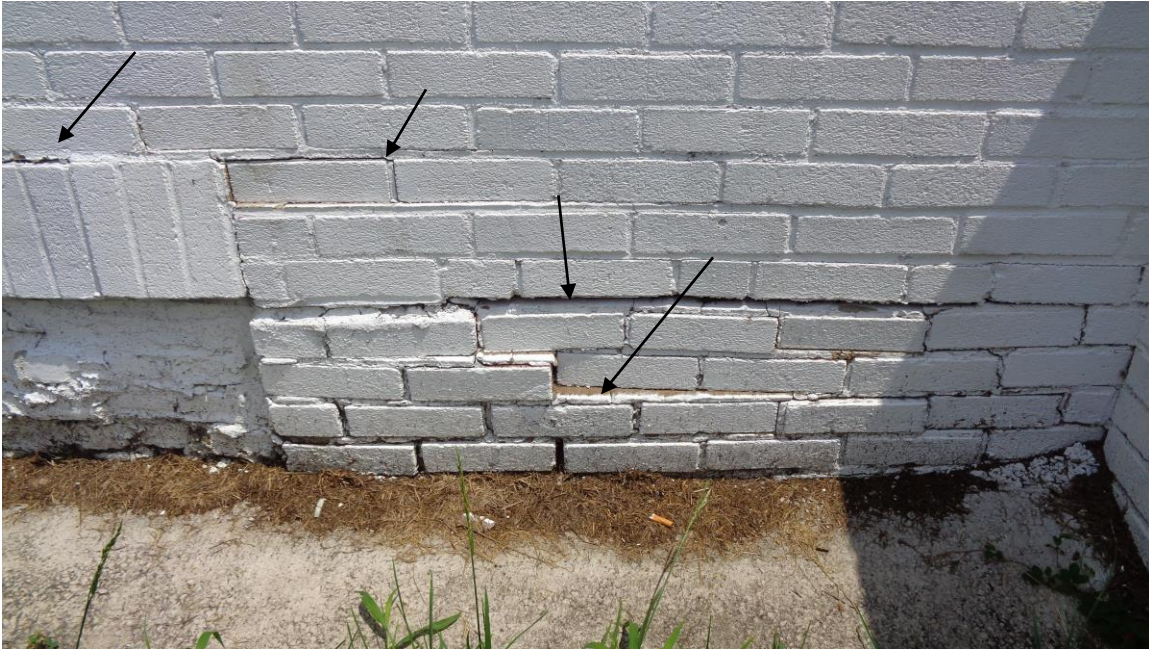
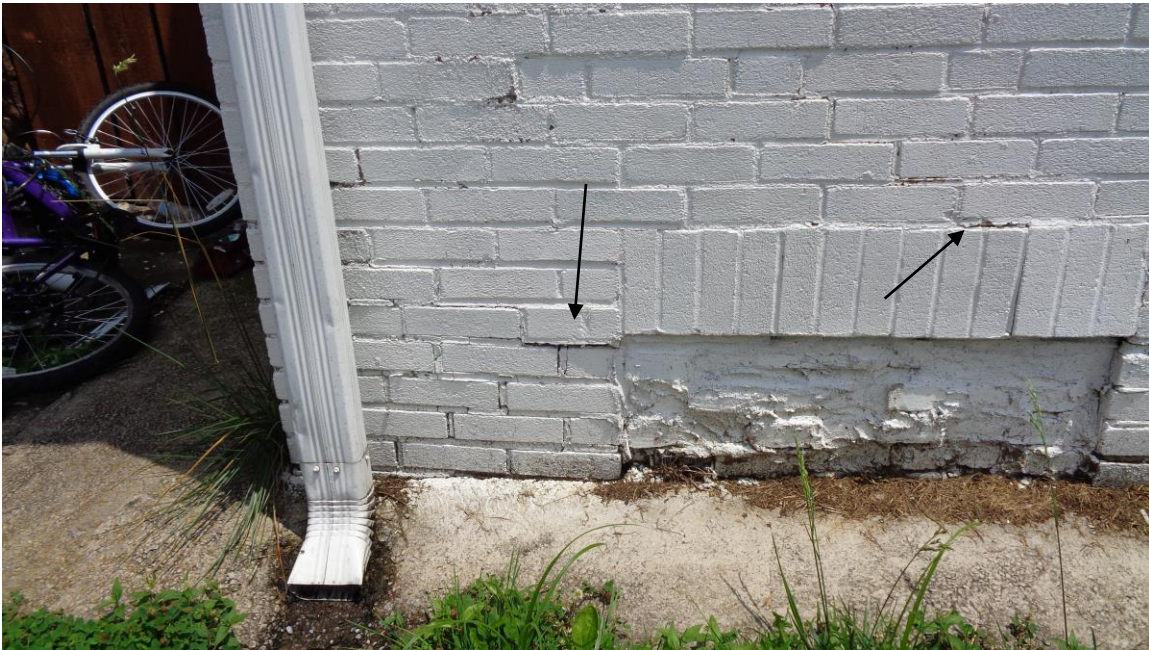
- The brick and mortar have cracked and moved under the front porch right of the steps.

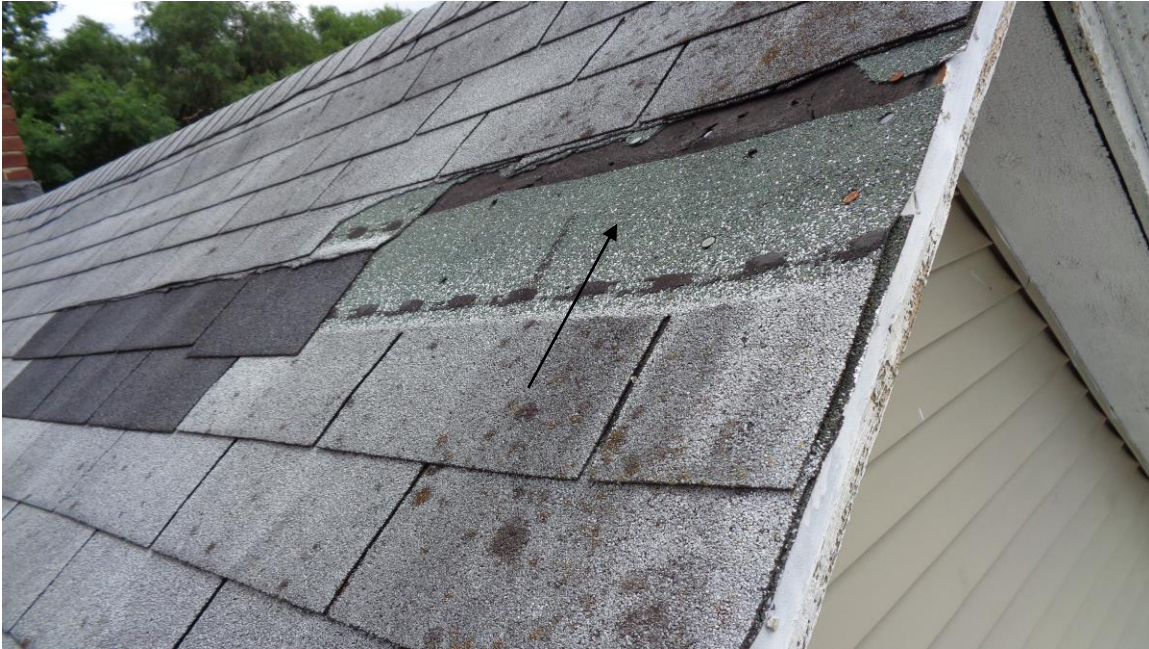
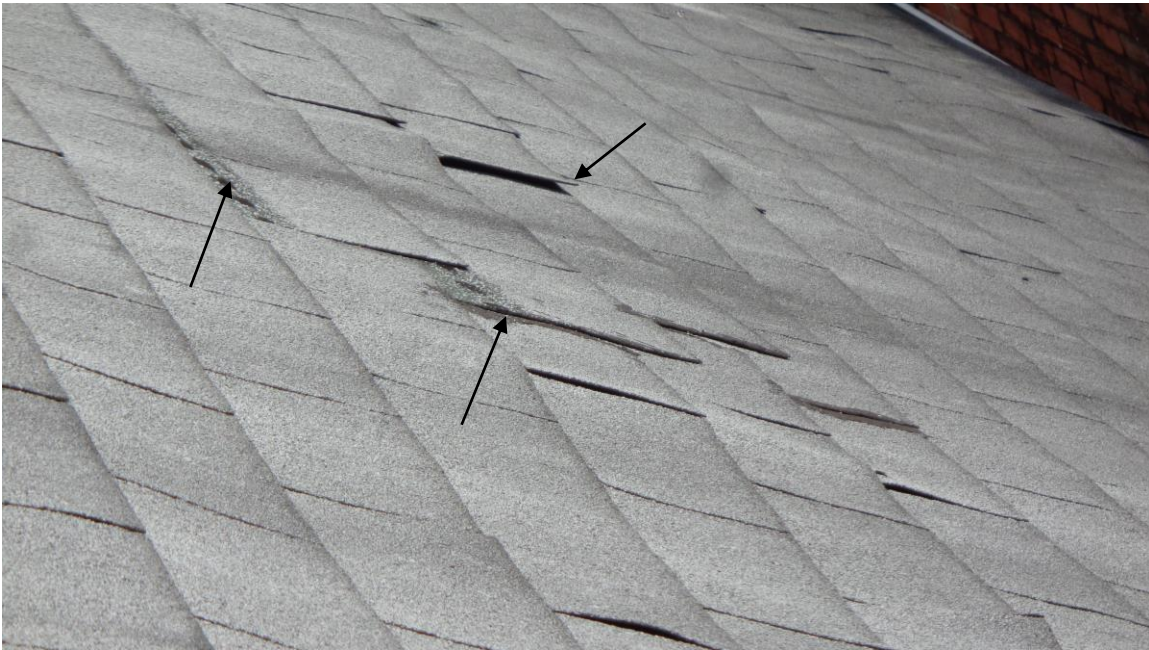
- I found 10+ shingles that are missing or loose on the main house roof. I recommend a roofing contractor evaluate and repair as needed. It is probable that the shingles need to be replaced.

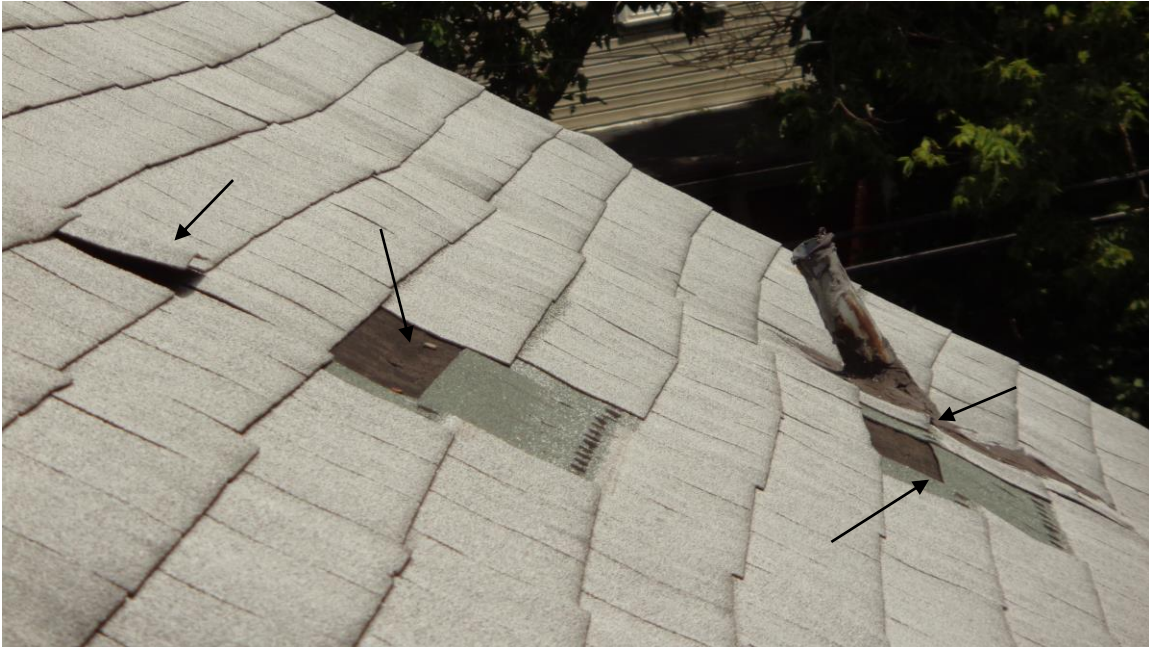
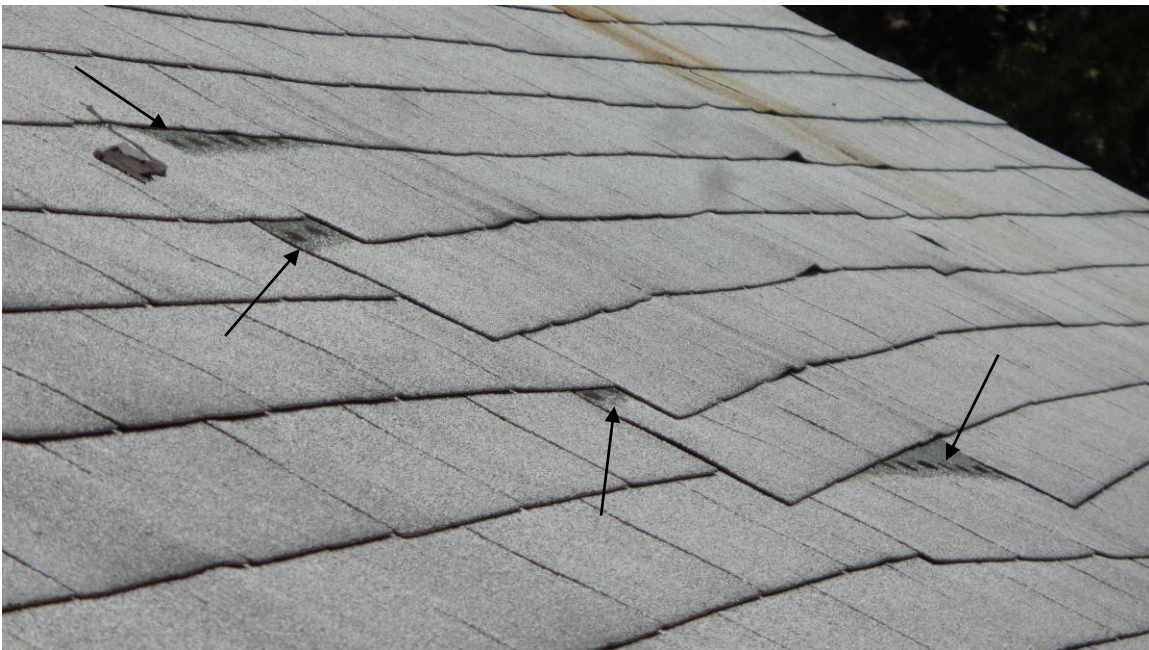
- I found 10+ shingles that are missing or loose on the main house roof. I recommend a roofing contractor evaluate and repair as needed. It is probable that the shingles need to be replaced.

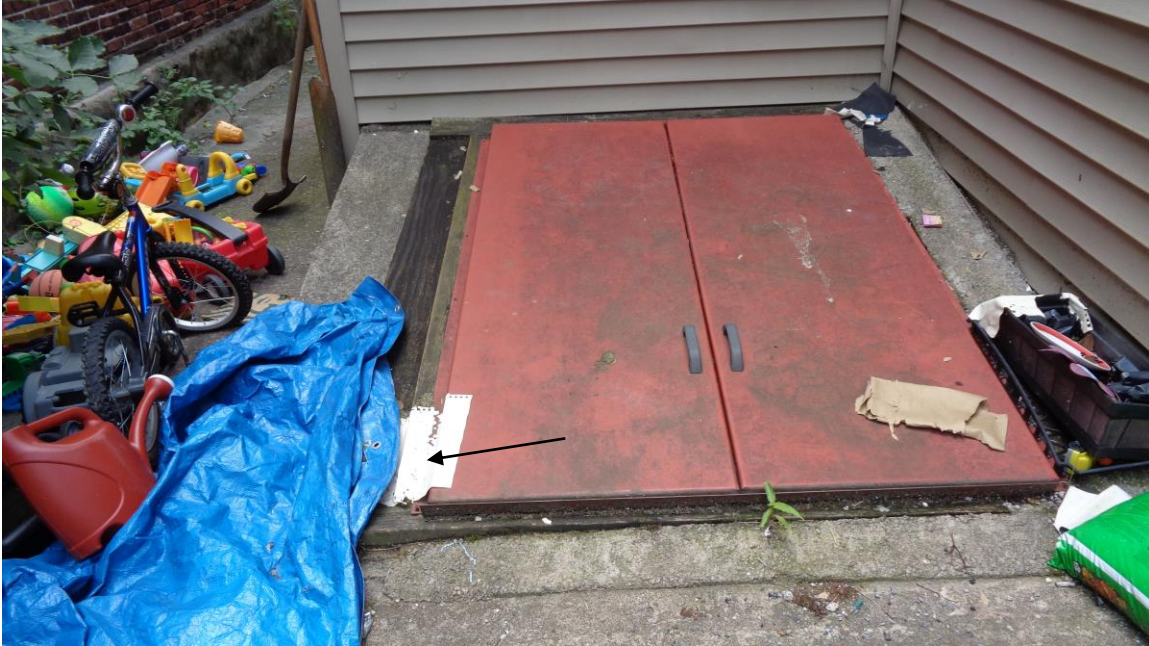
- Rotted wood that frames in the metal exterior doors to the basement.

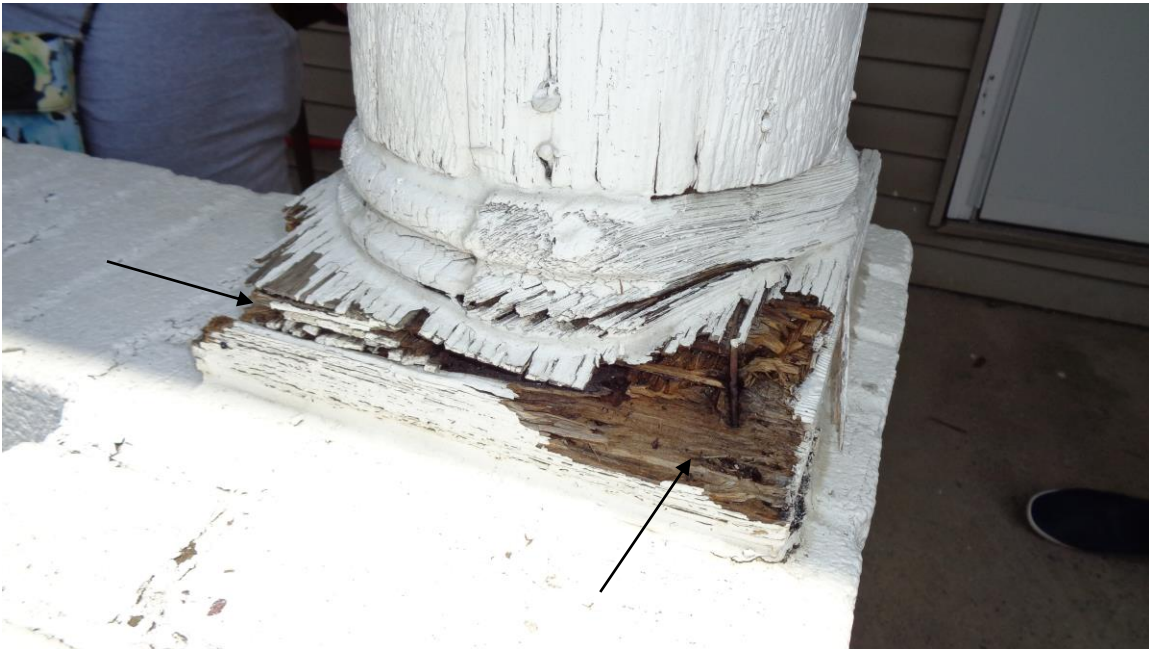
- Rotted wood on three of the front porch columns.

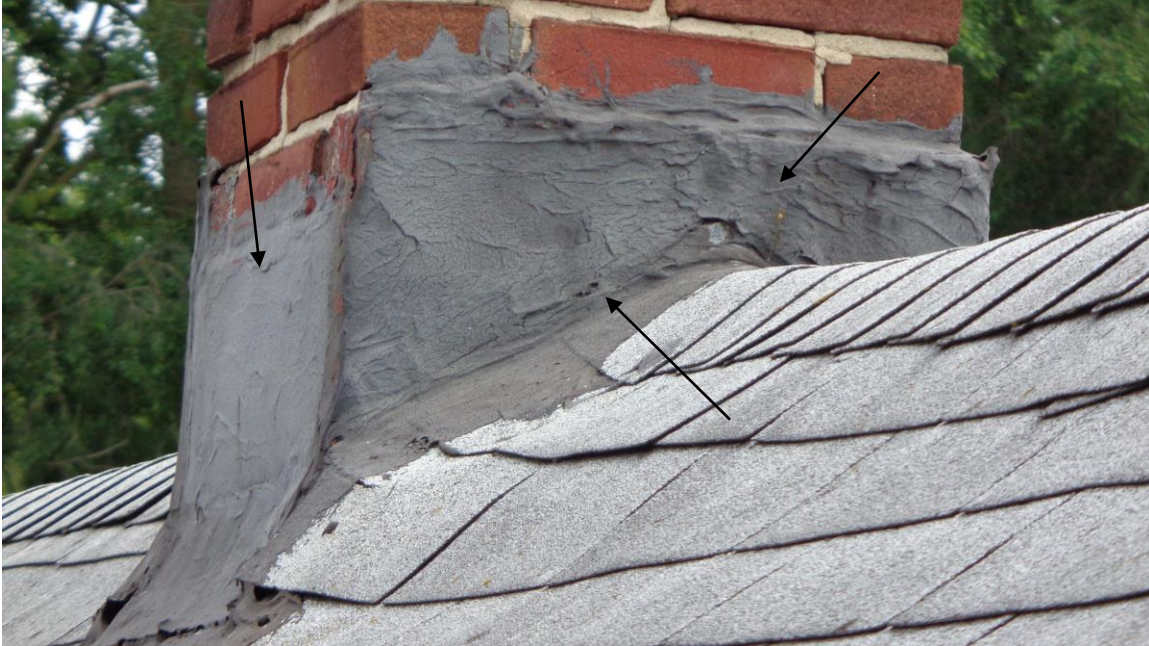
- The chimney flashing is tarred. You must maintain the tar to prevent water leakage or replace with proper flashing.

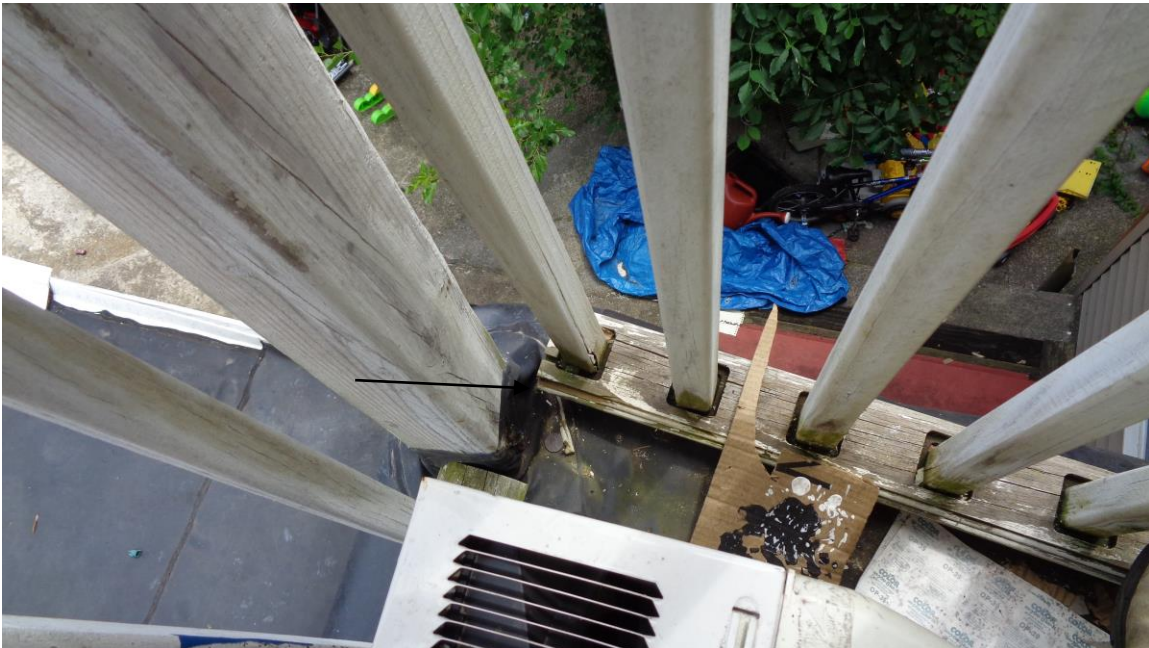
- Loose railing on the right side of the rear balcony.

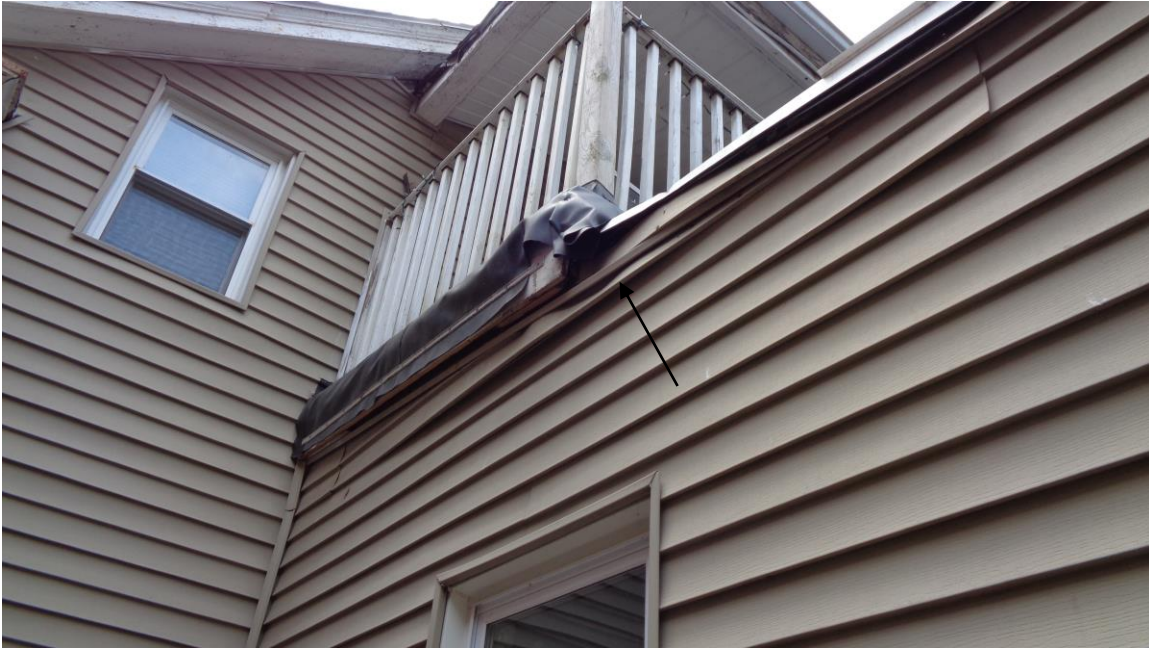
- Gap where the rubber roof intersects the balcony.

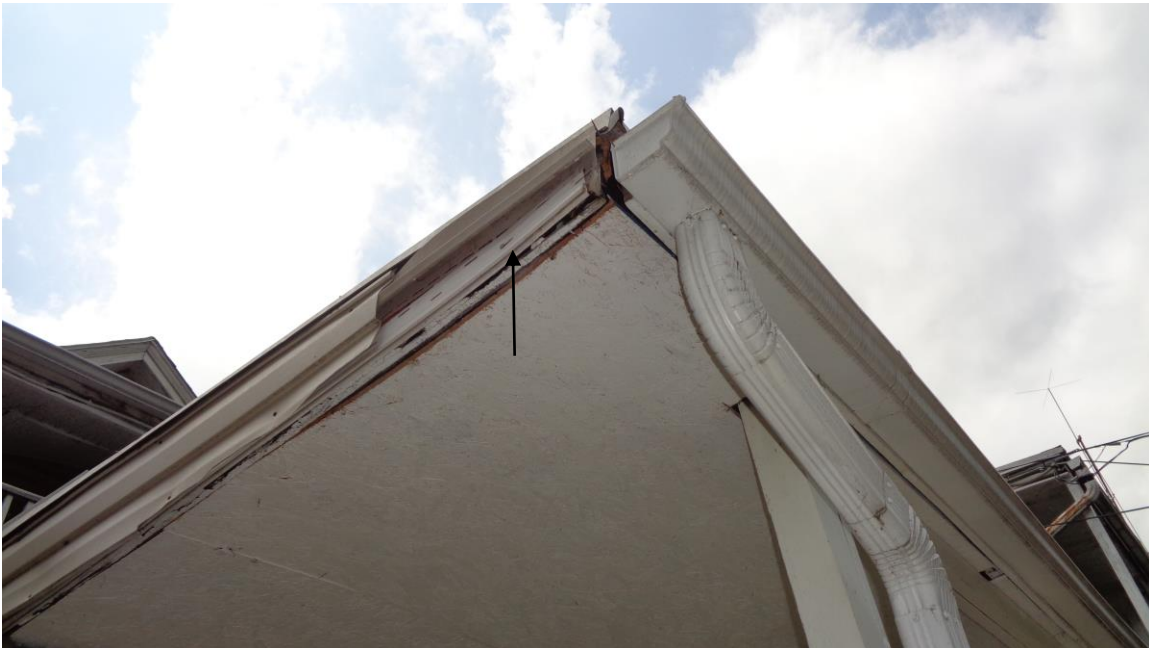
- Loose trim, gap in trim on the side of the rear rubber roof.

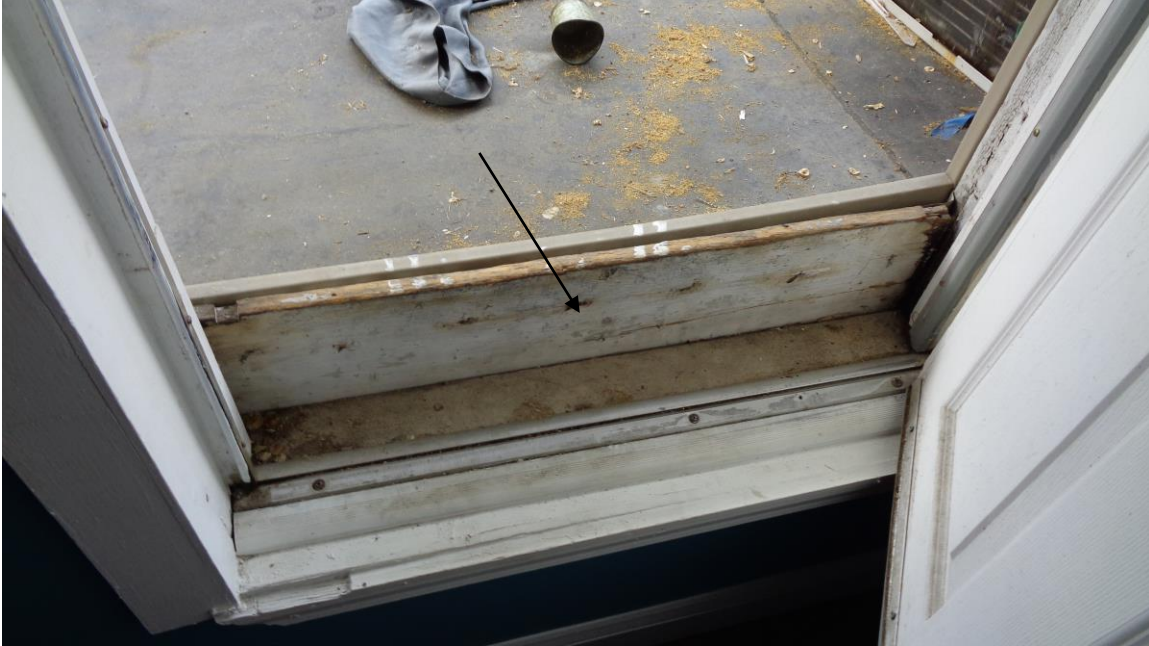
- Weather strip needed the exterior door to the balcony.
- The balcony door threshold is lower than the balcony floor.

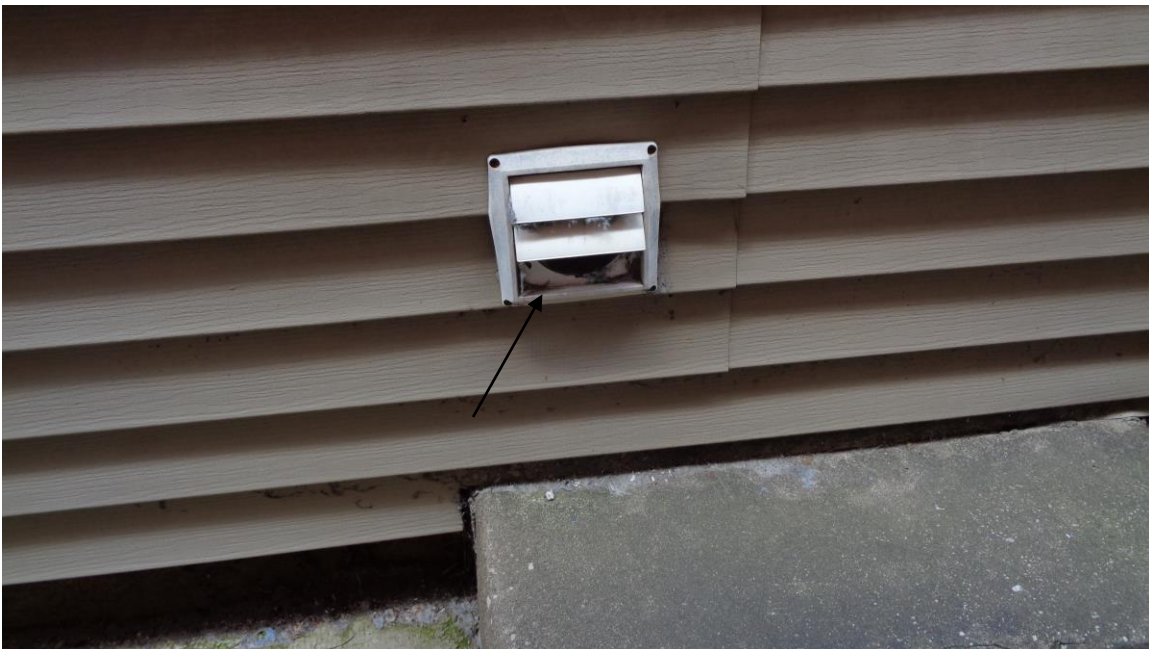
- The exterior dryer vent cover is broken.

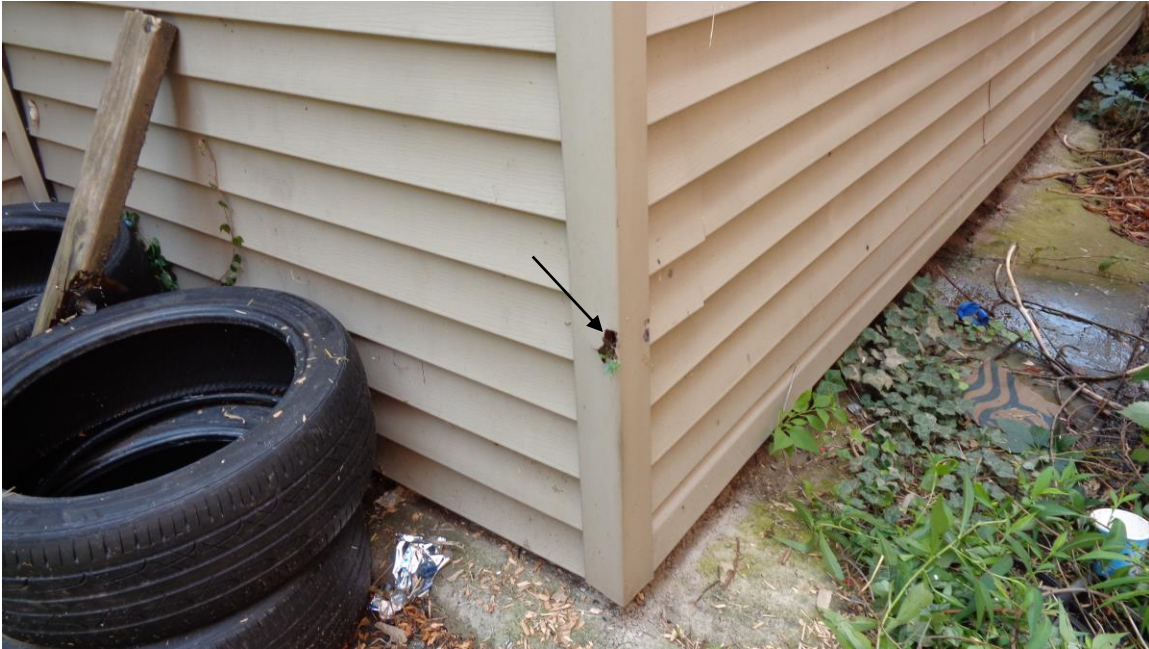
- Minor siding damage on the left rear corner of the house.

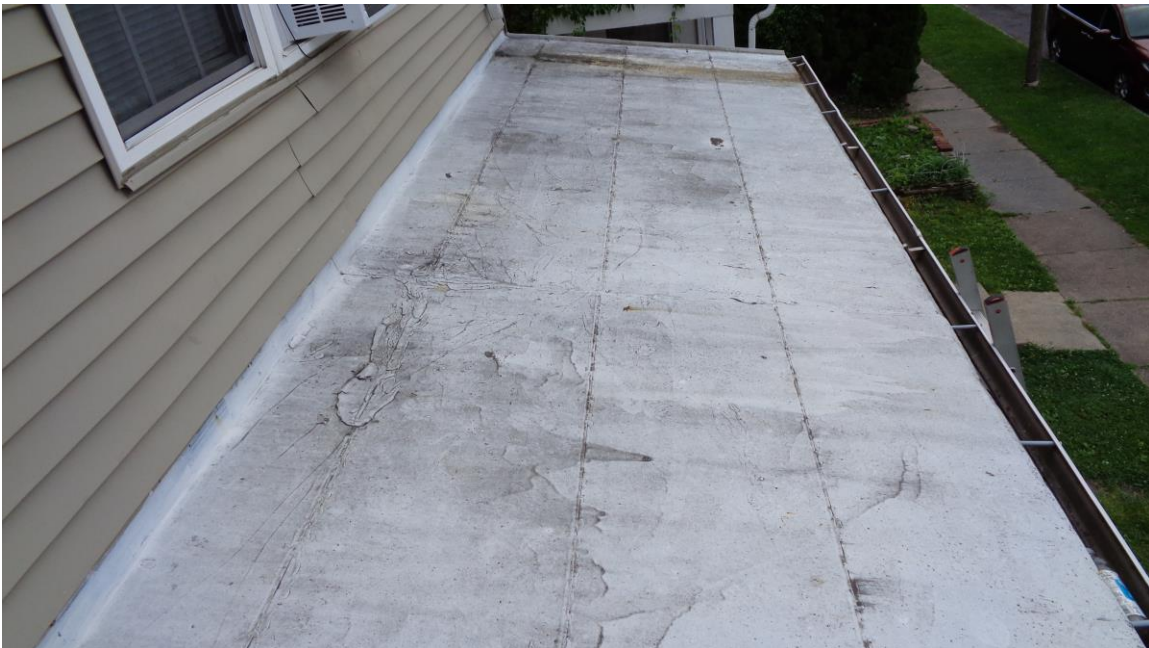
- It is important to maintain the coating on the metal front porch roof.

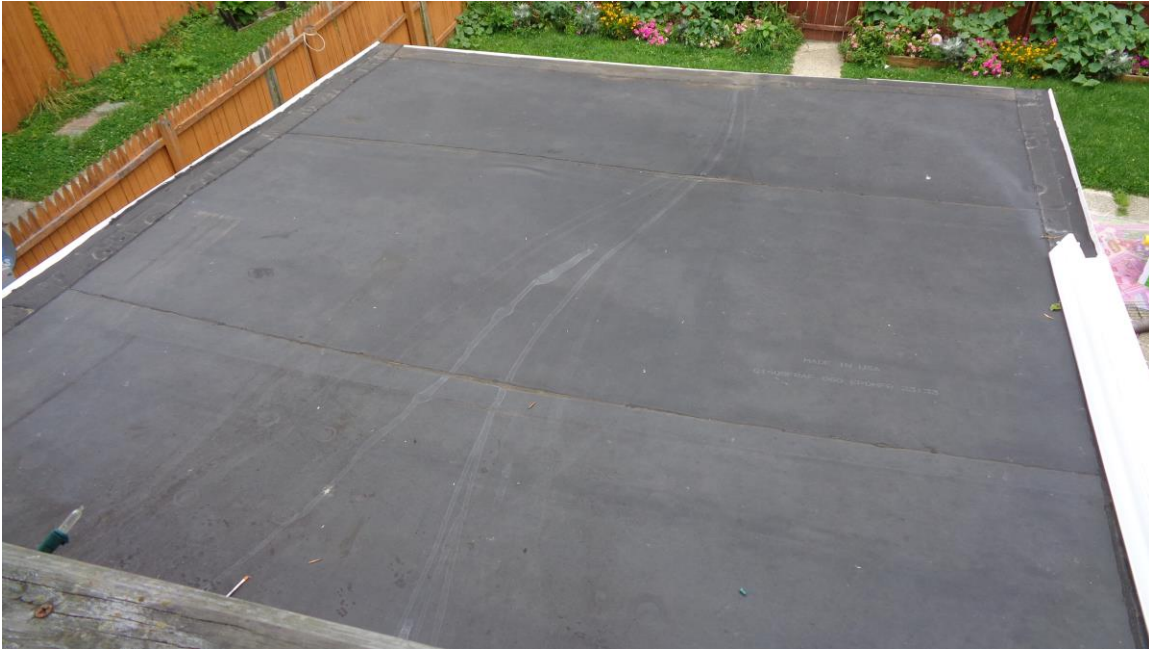
- The rubber roof material is in good condition. Rubber roofs typically last 30+/- years.

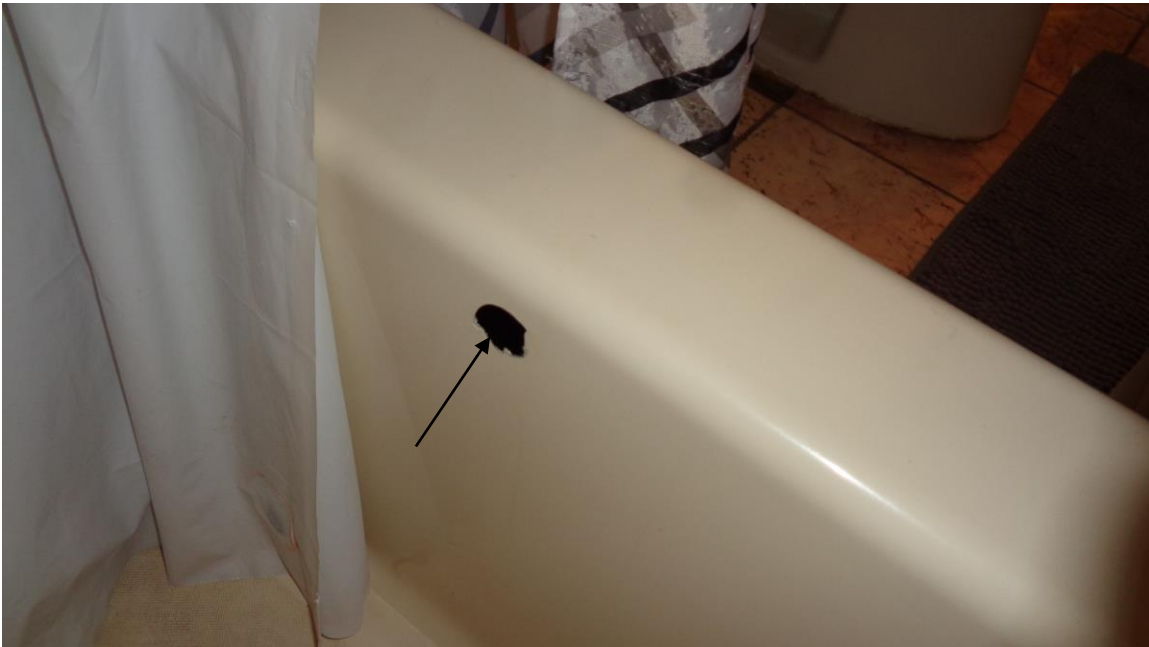
- There is a hole in the side of the bathtub in the 1st floor bathroom.

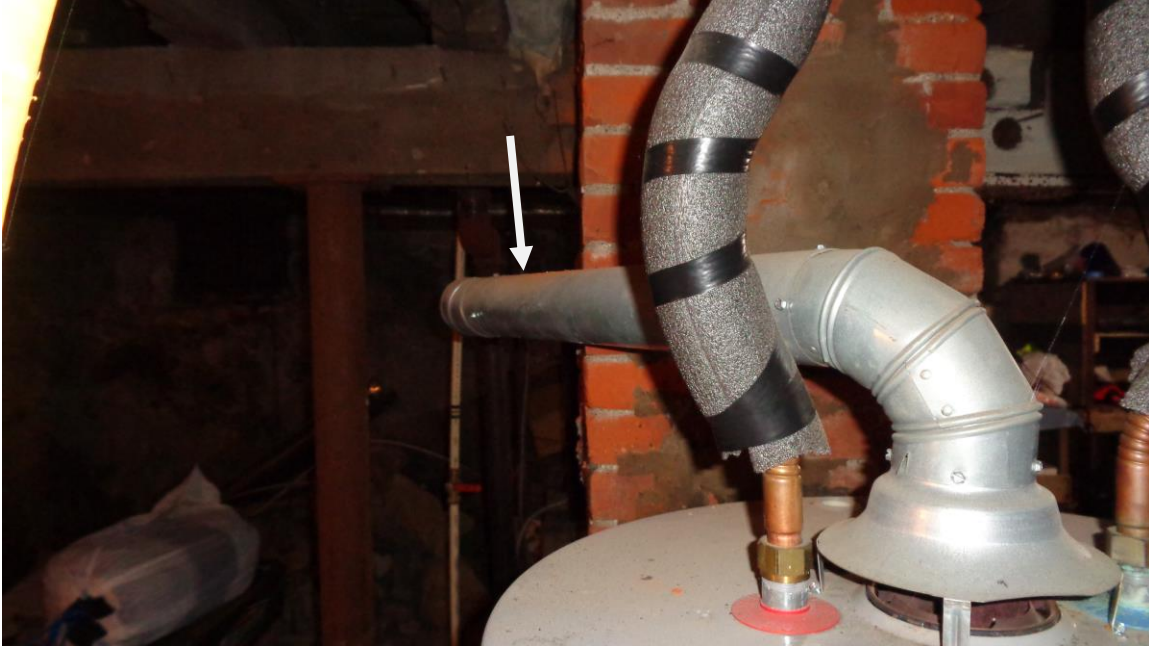
- The flue pipe on the water heater is not sloped properly. This could allow carbon monoxide to enter the house. It is important to correct this slope or install a power fan.

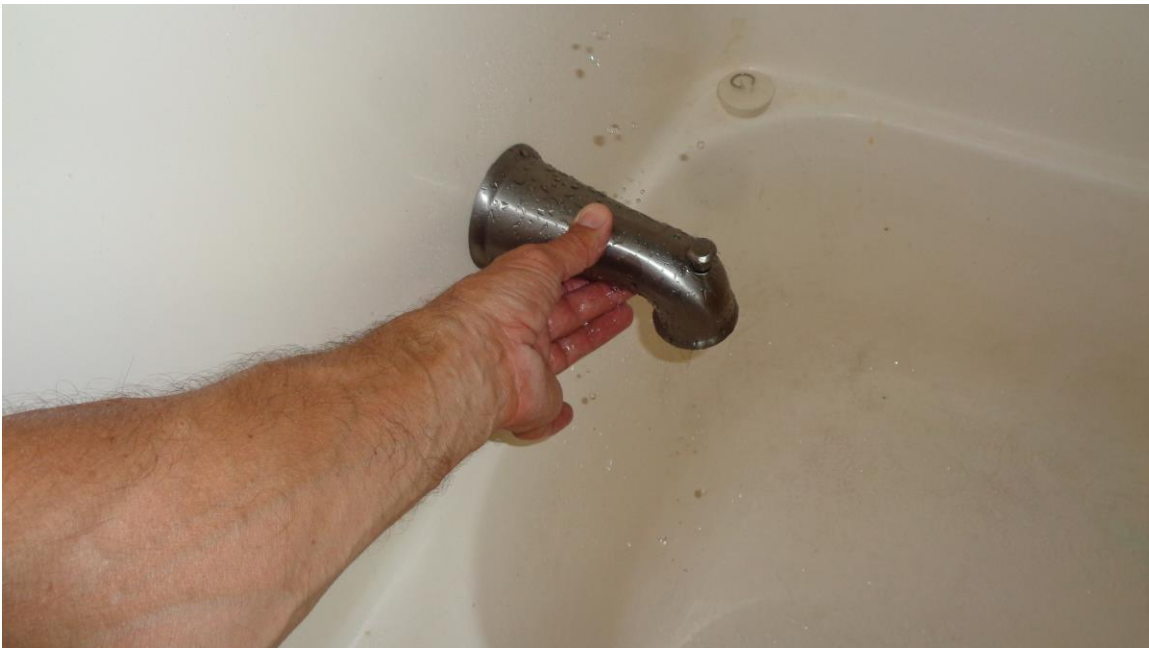
- The pipes for the tub spouts are loose in the wall. Both bathrooms.

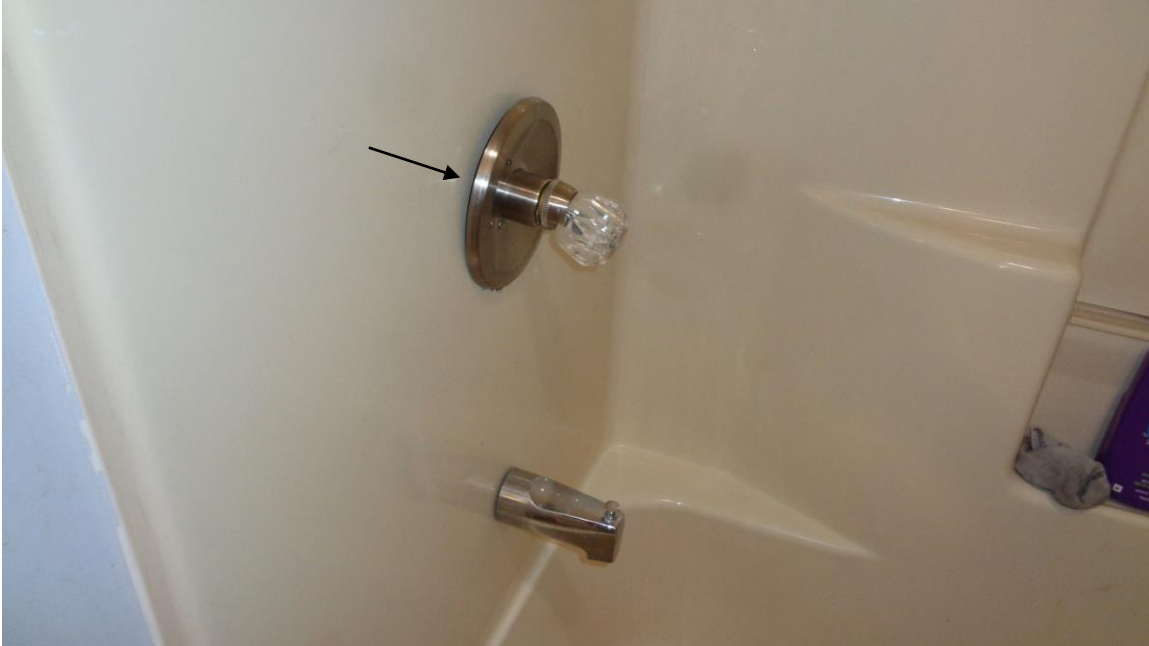
- There is a gap at the water control in the 1st floor bathroom. Water could get behind the fixture when showering.

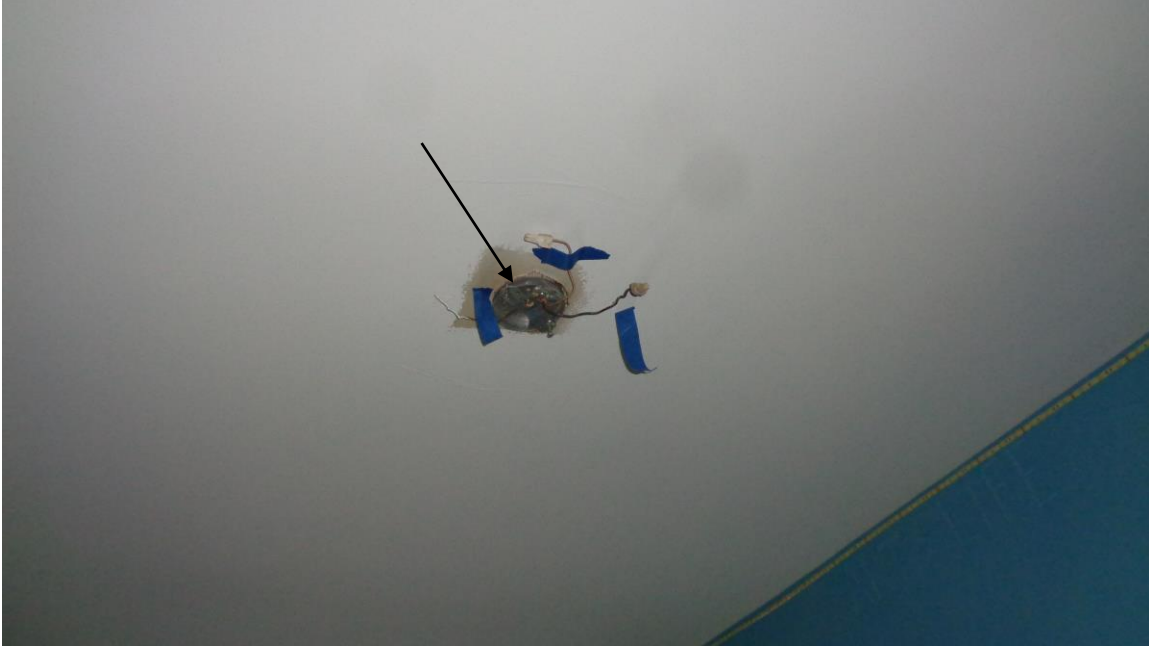
- Ceiling light missing in the left 2nd floor bedroom.
