Property Address, Pa

INSPECTION CENTER

by Mike Biechler Inc.

Full Home Inspection
Wood Pest Inspection
EIFS Inspection
Radon Testing
Water Testing
Mold Testing

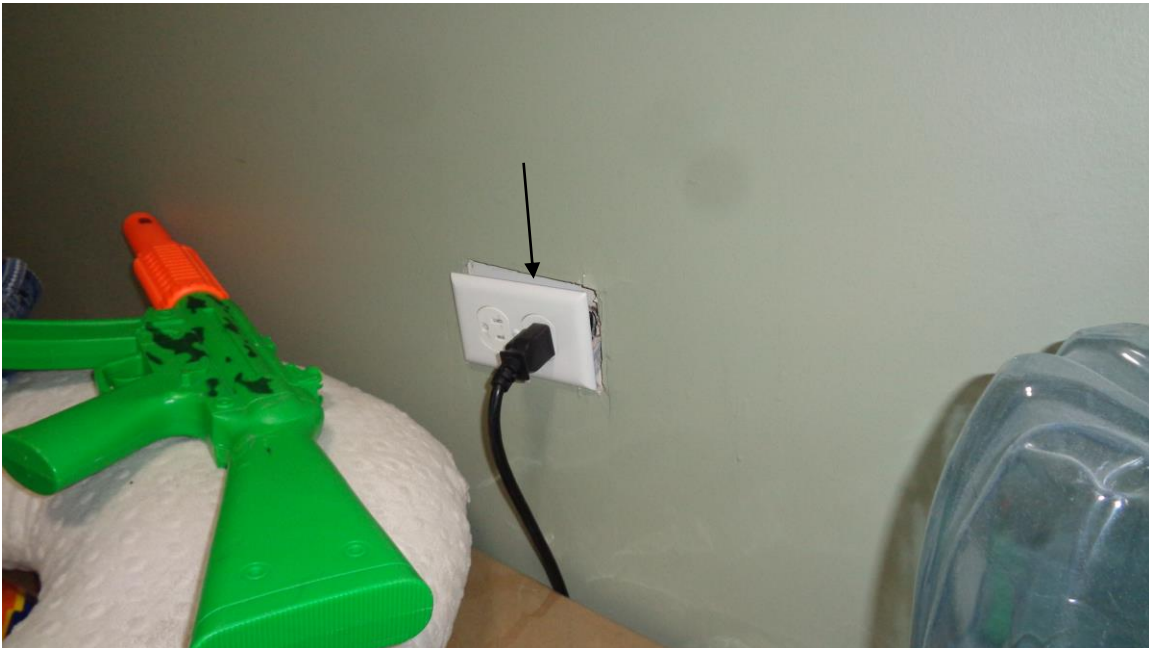
- Receptacle loose in the wall – laundry room.

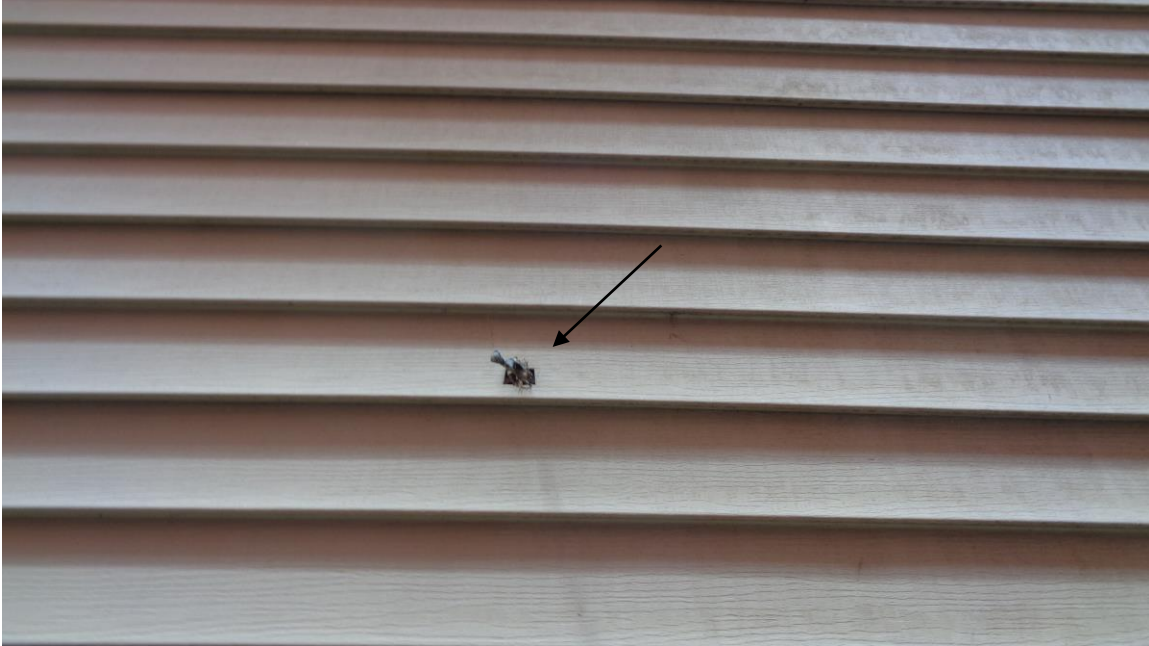
- There is a wire sticking out the right exterior wall. The wire should be eliminated or end in a junction box.

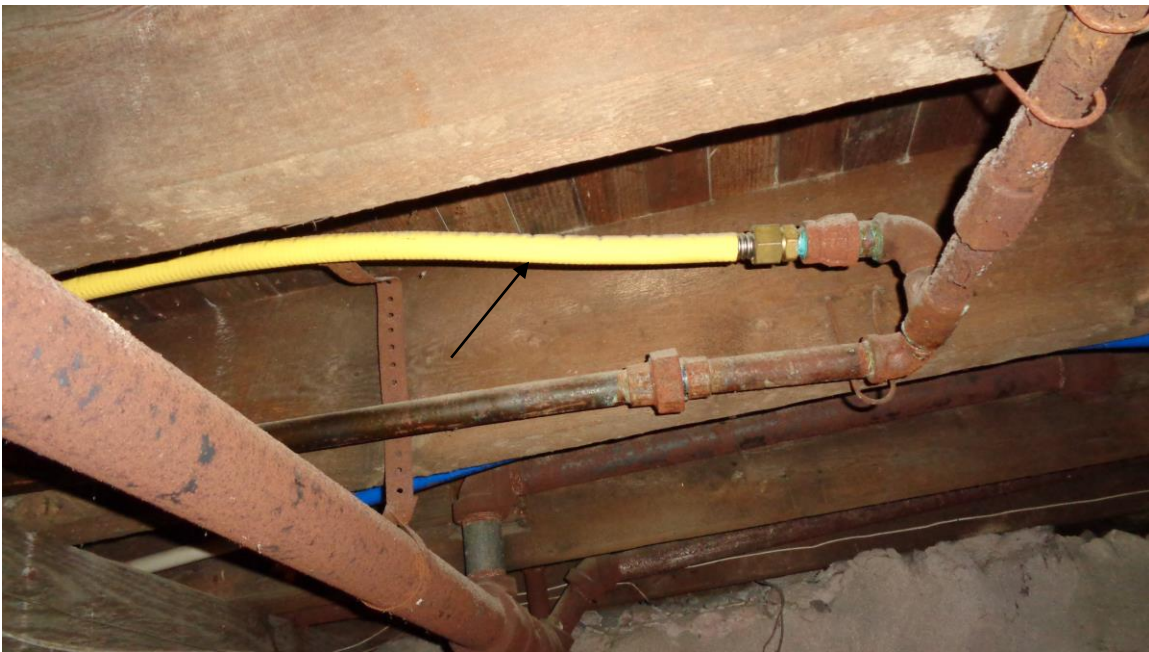
- Yellow gas flex pipe is used and I did not see a bonding strap on the steel gas pipe. The manufacture of the yellow gas flex pipe requires the steel pipe to be bonded to help prevent the pipe from bursting if lightning strikes close to the house.

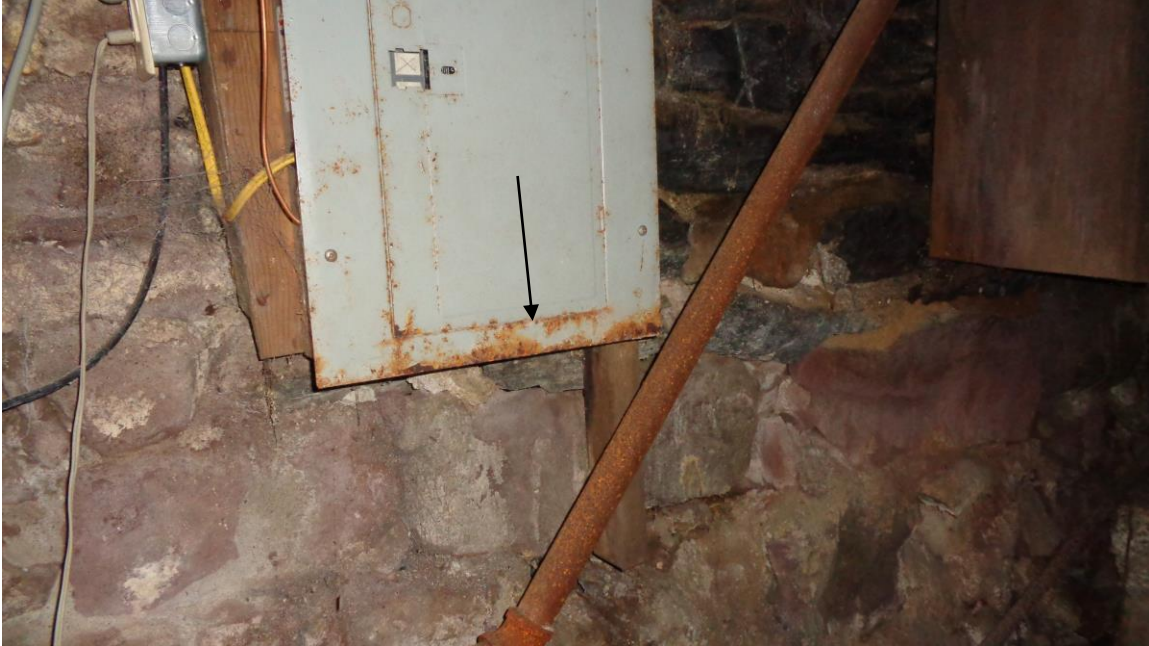
- The cover on the main electric panel box is rusted. I found no rust on the breakers.
- One pointed screw used to hold the cover on the main electric panel box. The tip of the pointed screw should be ground flat.

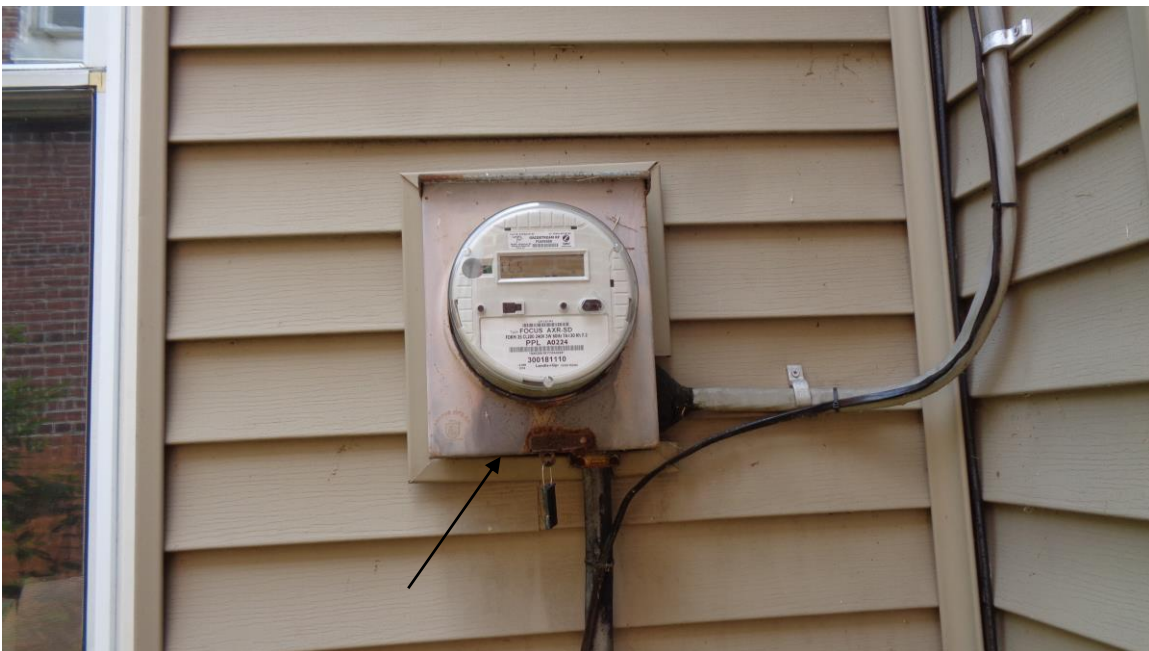
- The electric meter base is rusted.

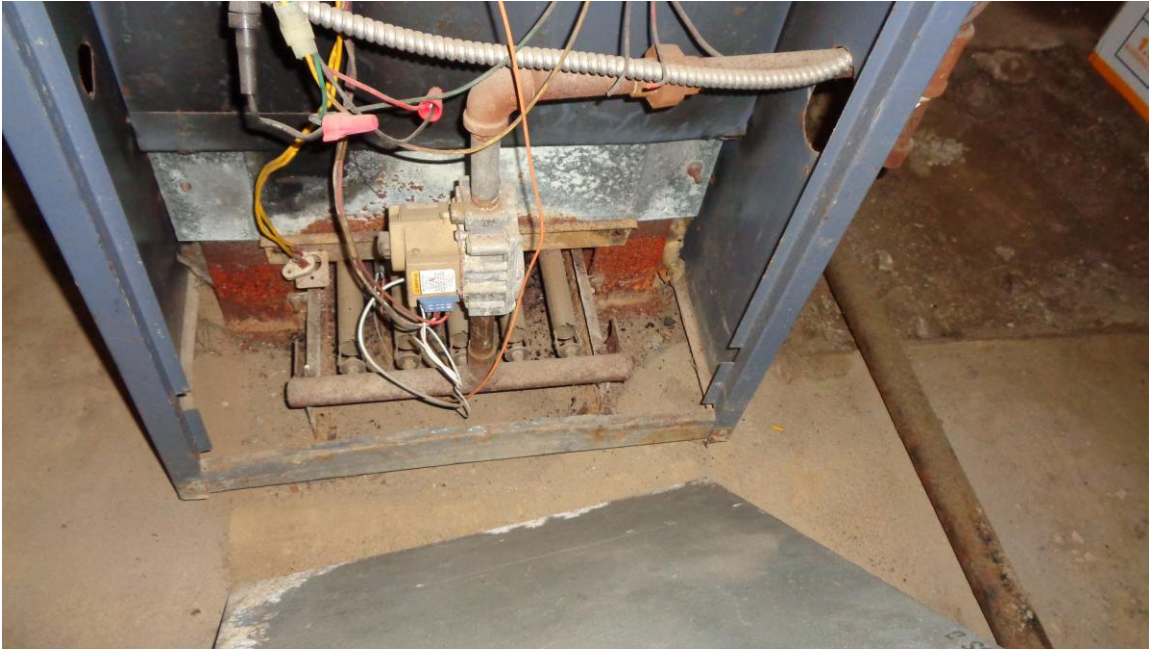
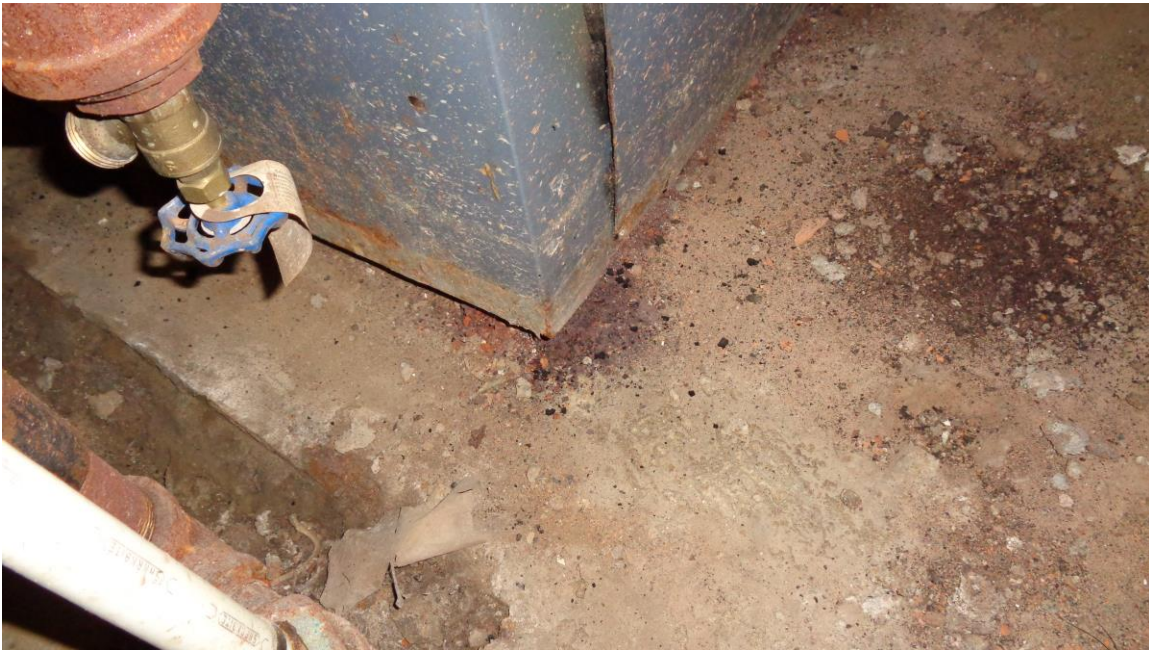
- The boiler would not turn on. There is rust around the bottom of the boiler. I recommend an HVAC contractor evaluate the heating system and repair as needed.

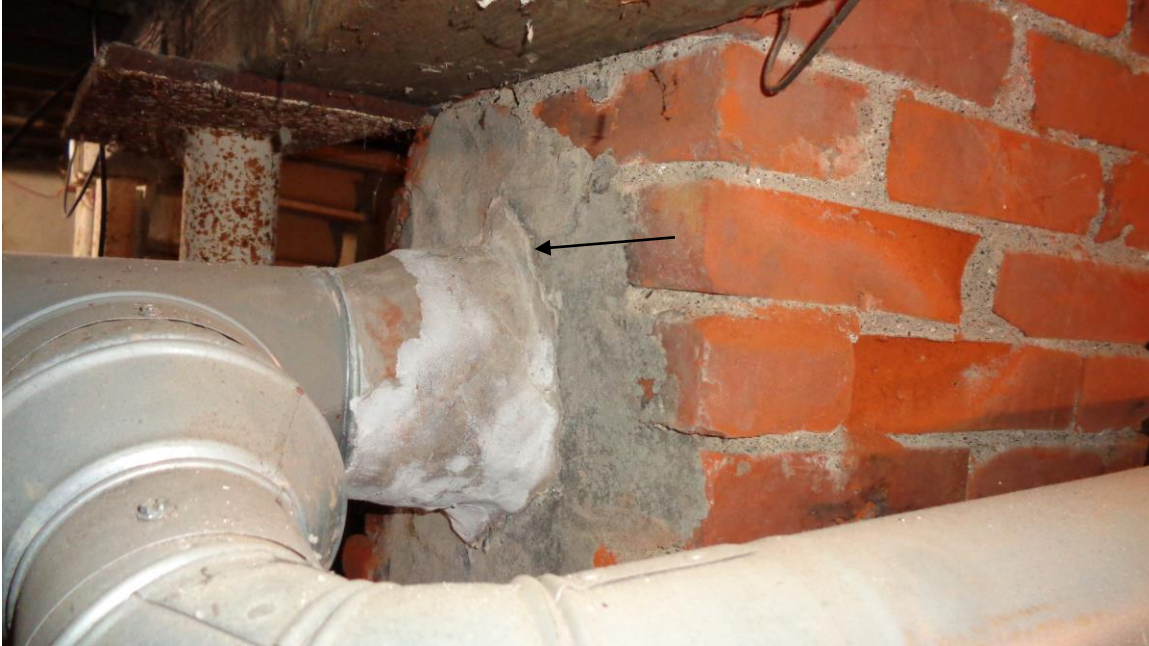
- Seal metal flue pipe where it enters the chimney in the basement.

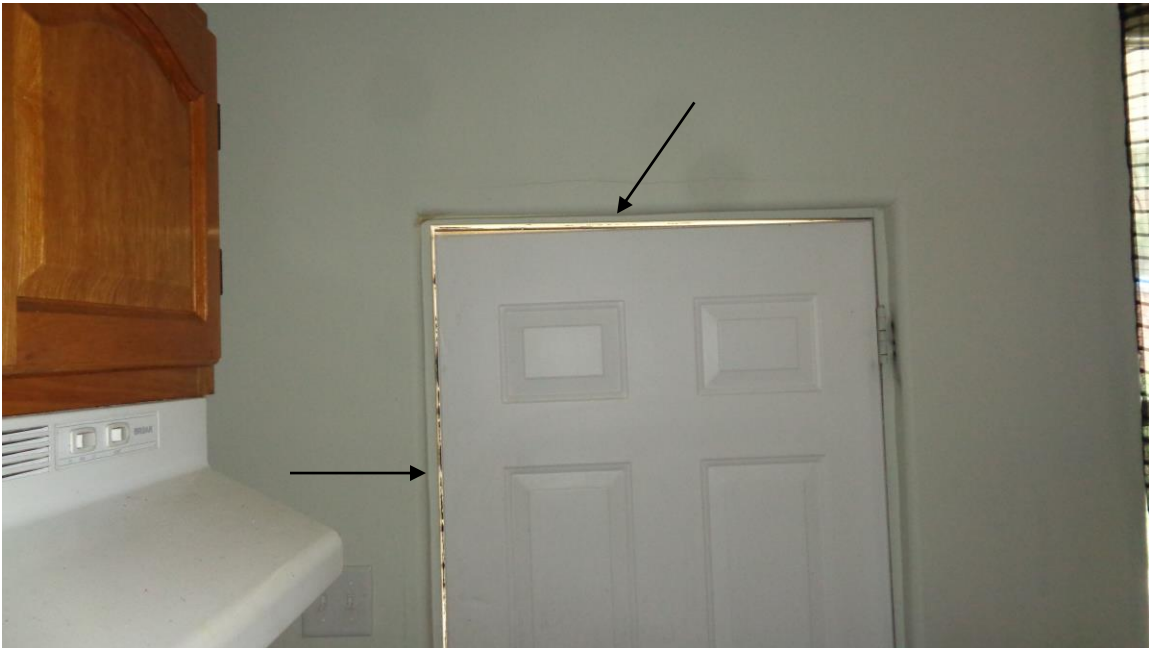
- The rear exterior door is not square in its opening. The threshold moves and the door does not close or lock properly. There is a large gap around the door when close.

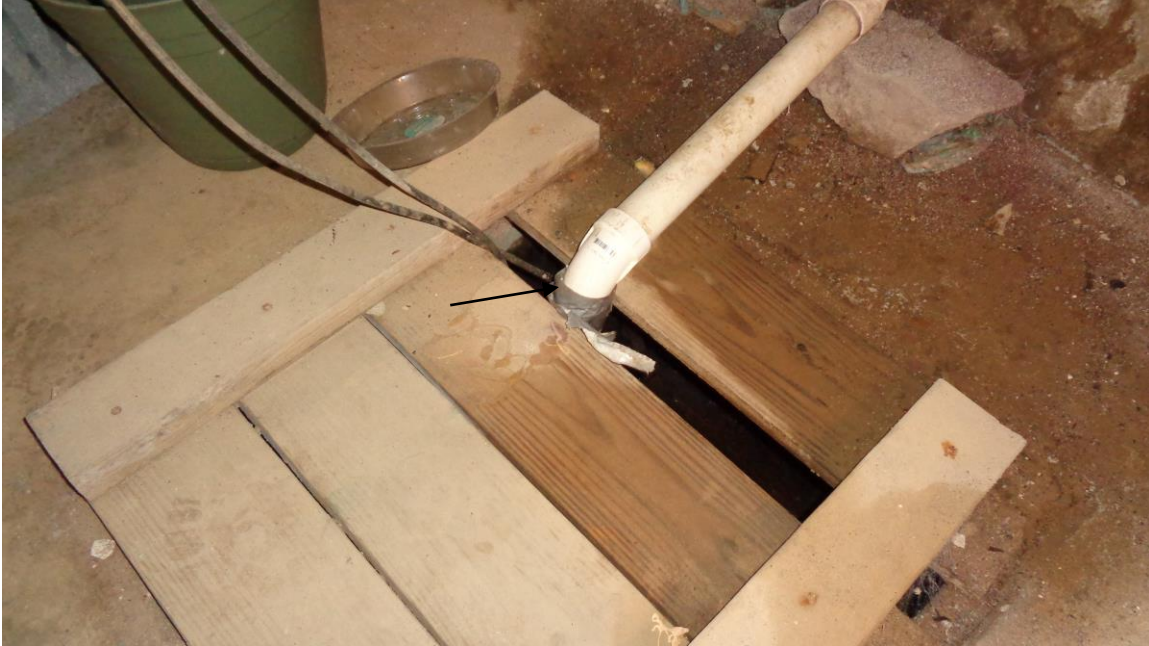
- The pipe on the sump pump is taped together.

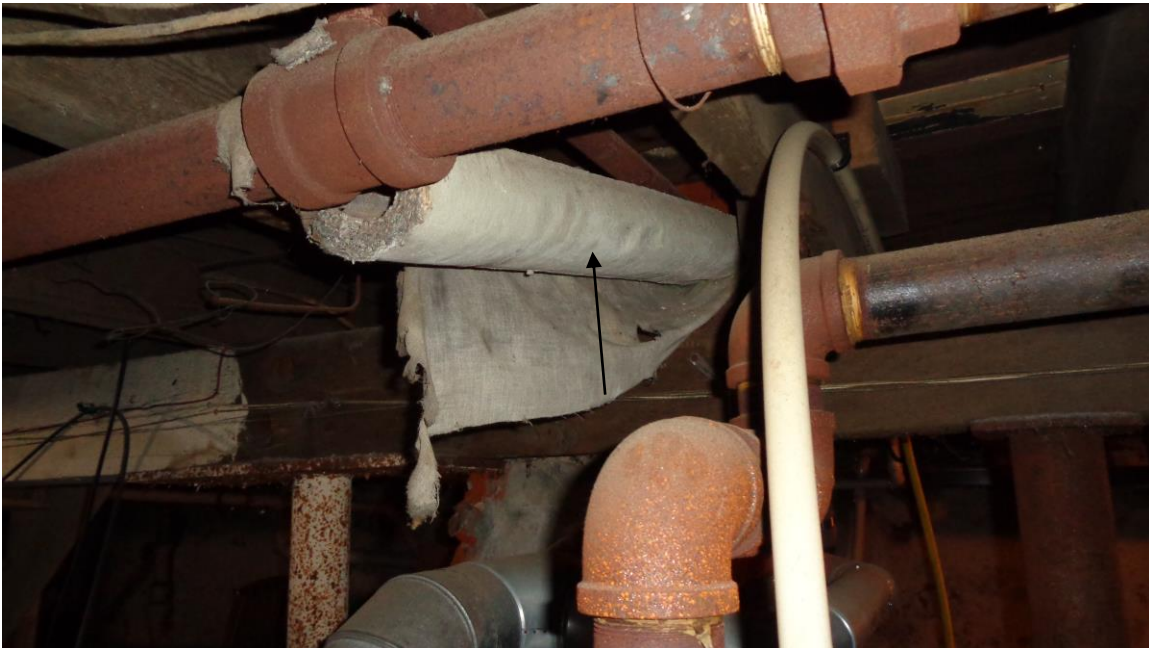
- The white insulation on some of the heat pipes in the basement may contain asbestos.

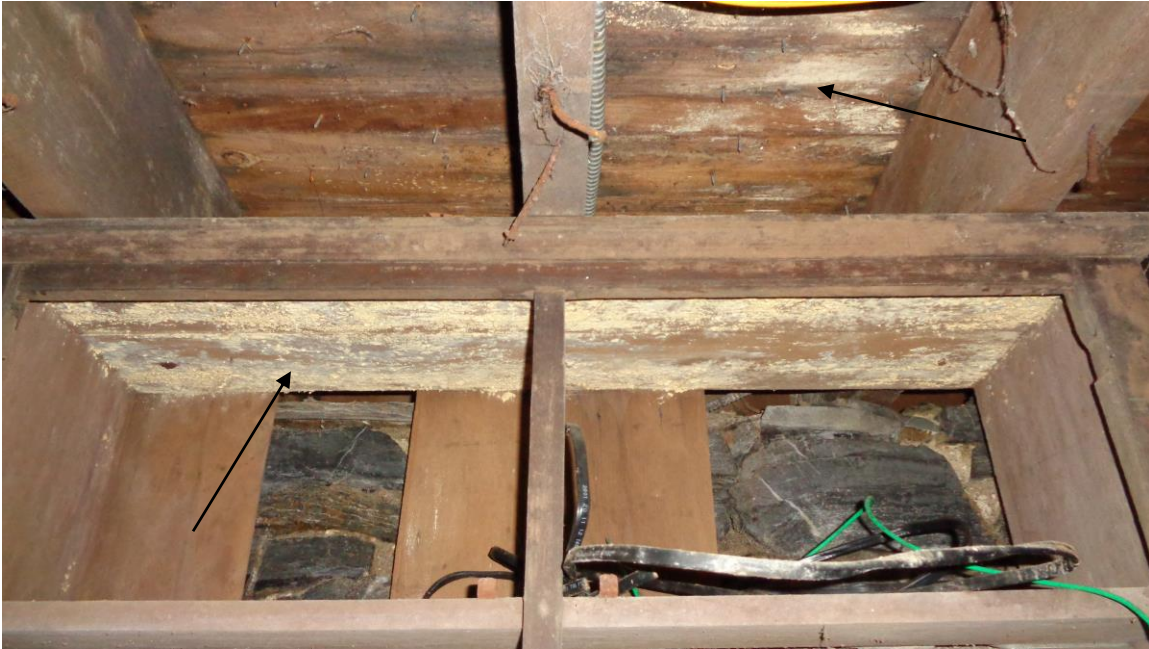
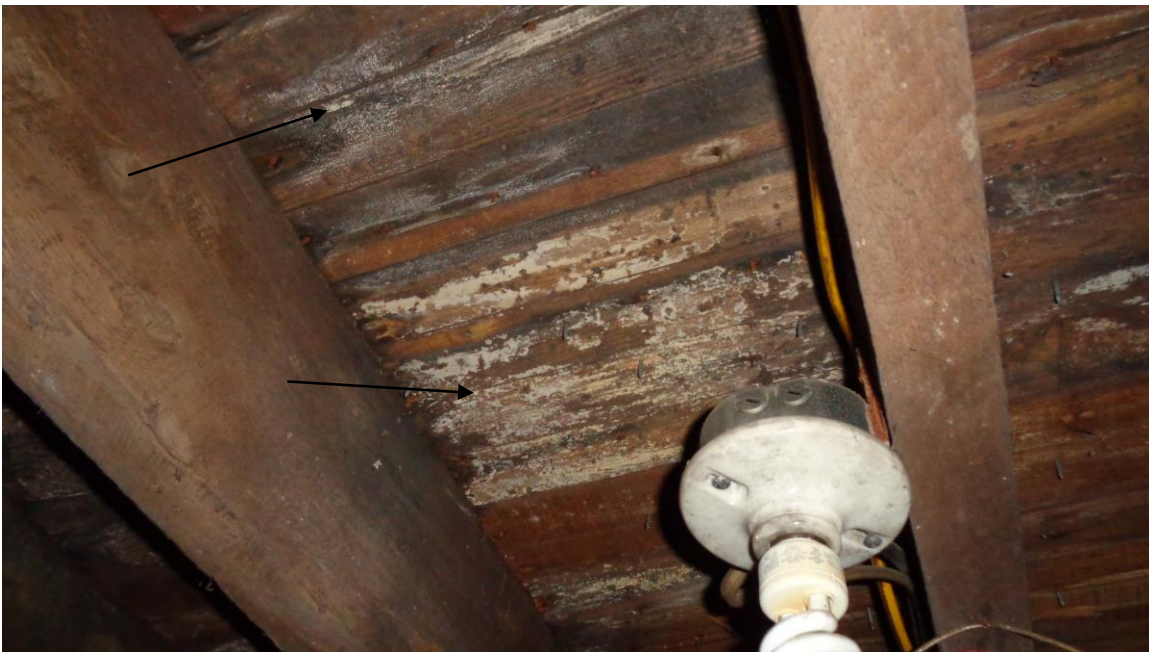
- Suspect mold growing on several floor joists and sub-floor in the basement.
